Project No.
4663.002.019

June 24, 2020

Subject: Jordan Ranch Development
Positano Development
Dublin, California

**GEOLOGIC HAZARD ABATEMENT DISTRICT
MONITORING – SPRING 2020**

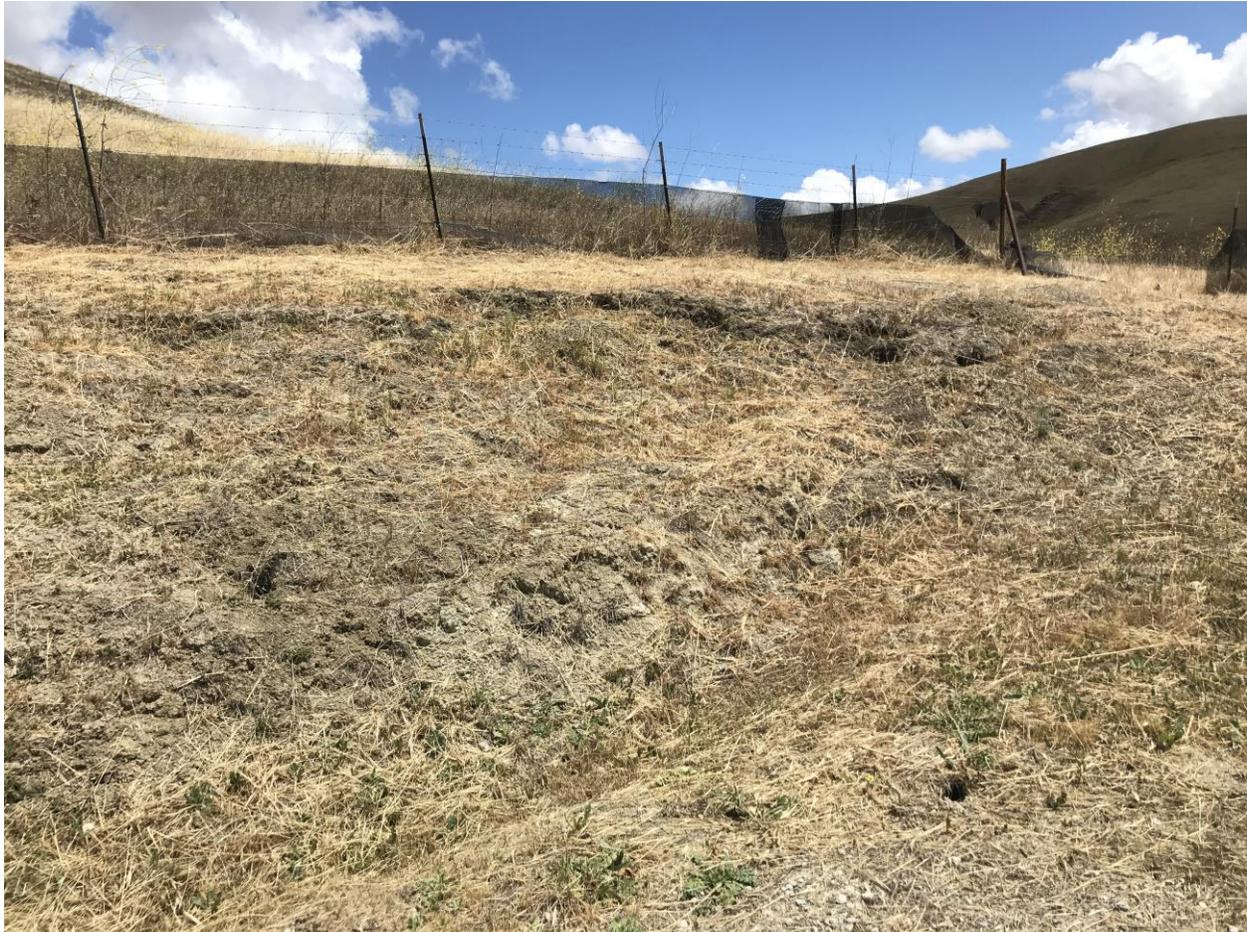
PHOTOGRAPH 1: Site Condition D

To the east of the previously mentioned landslide (Site Condition C), there was a minor landslide that appears to be caused by numerous shallow animal burrows (Figure 2, Site Condition D, Photograph 1). The landslide measures approximately 15 feet in width, 10 feet in length, and has a head scarp of about 1 foot in height. The material deposited by the landslide was deposited in the earthen-lined drainage ditch located at the base of the slope. The GHAD will remove the deposited material and restore the earthen-lined drainage ditch. During our most recent monitoring event, it appears that another shallow failure has occurred as a result of the burrowing activity. This failure does not impact any nearby improvements and the GHAD will continue to monitor this slope.

Minor landslide above earthen-lined drainage ditch near Castello Court.

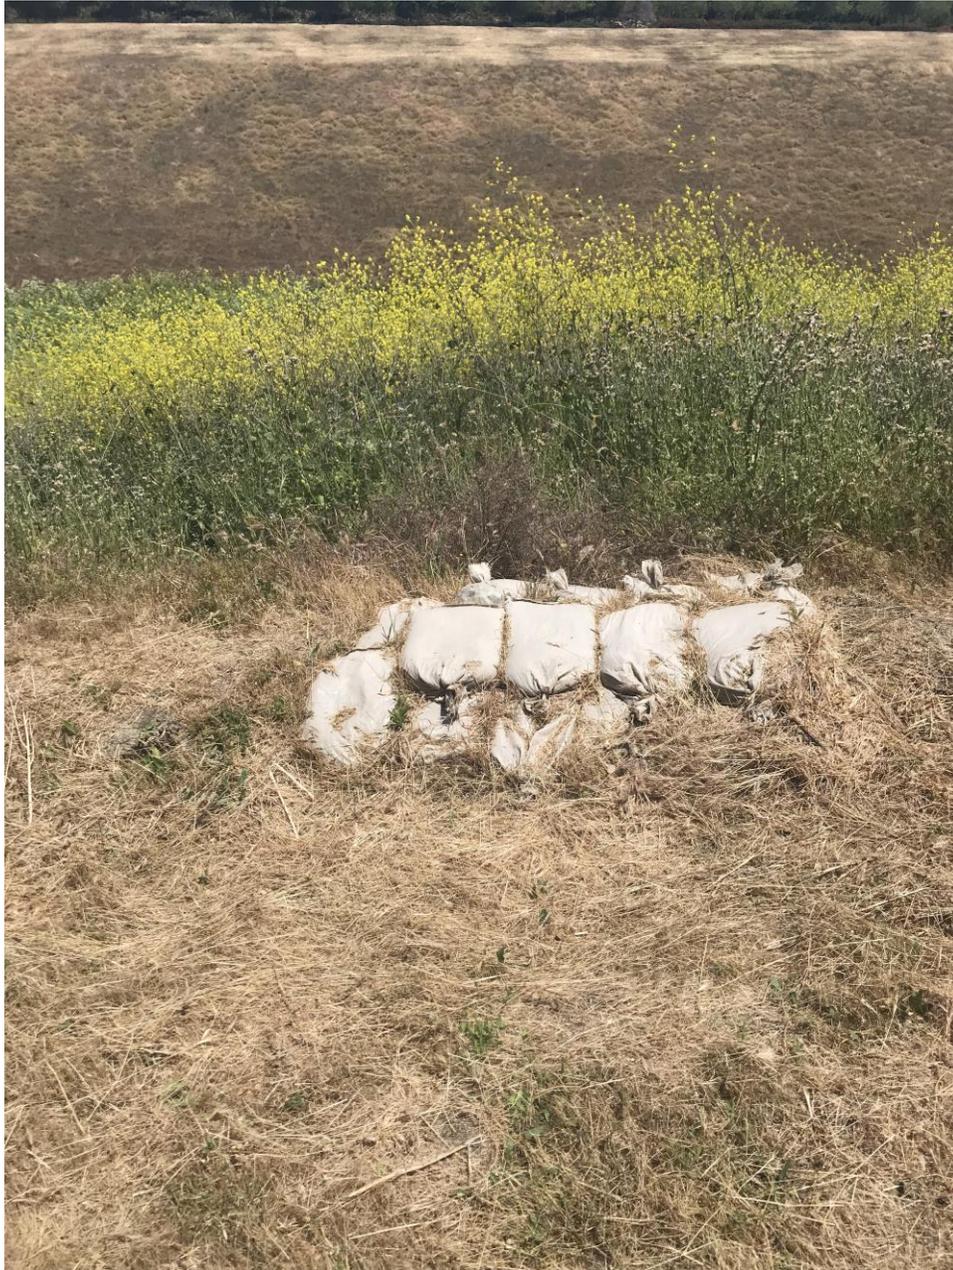
PHOTOGRAPH 2: Site Condition F

An erosion gully has formed downslope of an earthen-lined drainage ditch located immediately east of Jose Maria Amador Elementary School within the Positano development. The erosion gully, located at the top of the slope, was approximately 30 feet in length, up to 5 feet in width, and up to 3 feet in depth (Figure 2, Site Condition F, Photograph 2). The erosion gully appears to have started with surface water moving through animal burrows in the earthen-lined ditch. The GHAD implemented a temporary repair in fall 2018 to prevent further erosion. The GHAD will replace the existing earthen-lined drainage ditch with a concrete-lined drainage ditch.

Erosion gully with temporary repair downslope of earthen-lined drainage ditch east of Jose Maria Amador Elementary School.

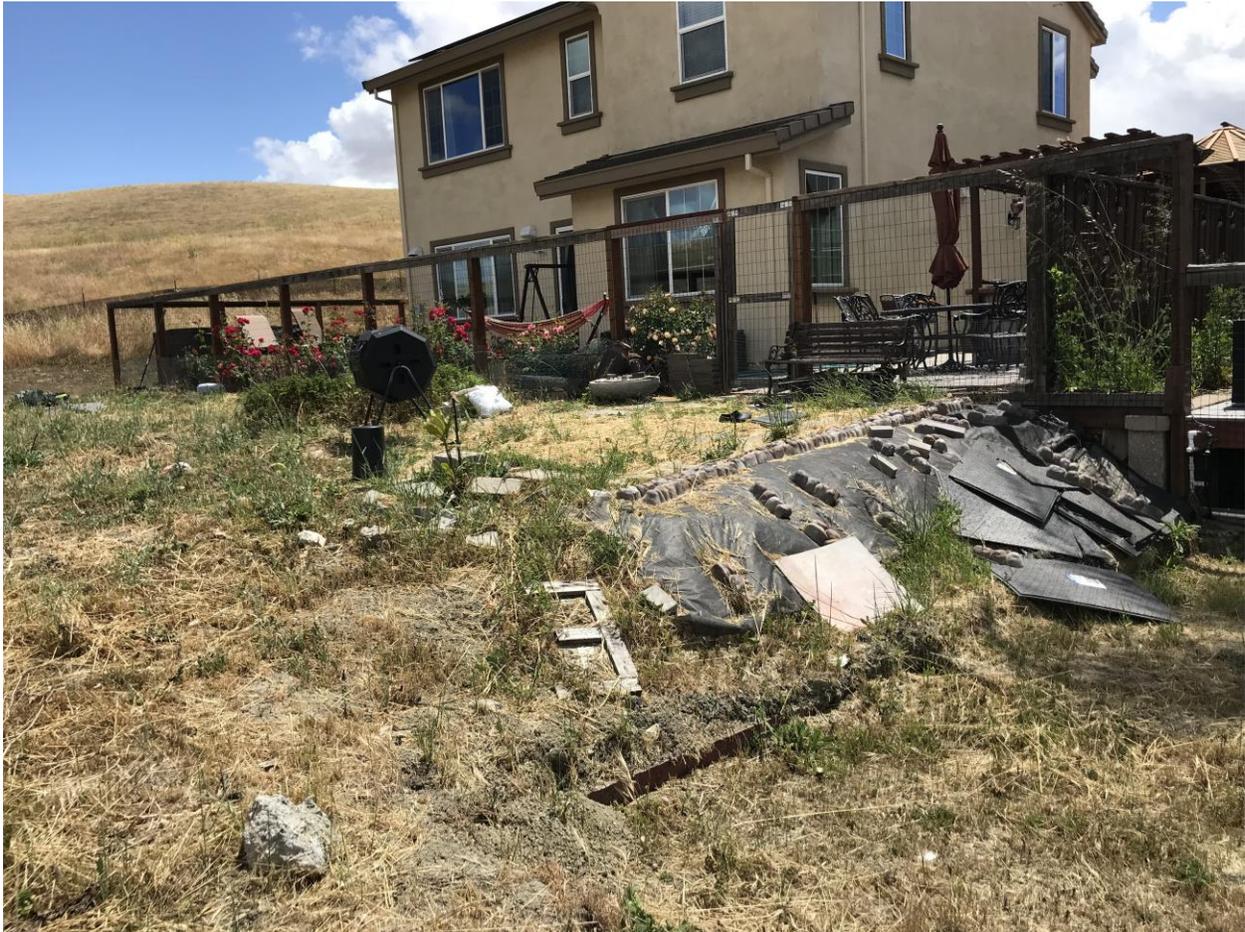
PHOTOGRAPH 3: Site Condition G

Within the open space north of Montese Court, we observed unauthorized homeowner improvements outside the property fence of 2101 Montese Court and 2109 Montese Court (Figure 2, Site Condition G, Photograph 3). The GHAD has notified the homeowners that these improvements are not allowed within the GHAD-owned open space and the GHAD has requested their removal. The homeowner has removed the fencing that was previously installed on the GHAD property; however, improvements to the slope between lots remains. This debris should also be removed and the GHAD will notify the homeowners.

Unauthorized homeowner improvements within GHAD-owned open space west of Montese Court.

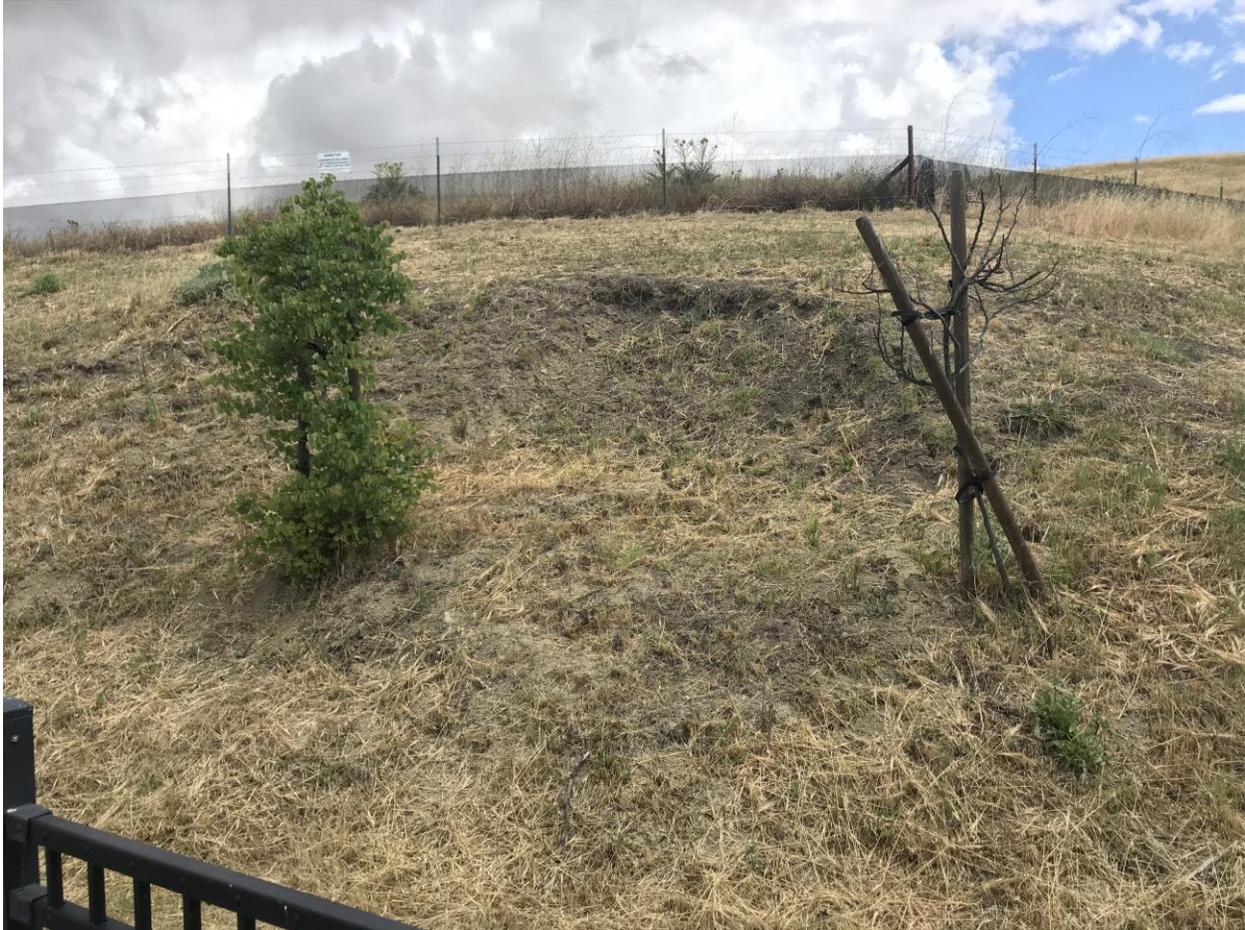
PHOTOGRAPH 4: Site Condition H

On the slope at the north end of Volterra Court, we observed a shallow landslide measuring approximately 20 feet in length, 10 feet wide, with a headscarp of about 1 foot deep (Figure 2, Site Condition H, Photograph 4). At the time of our monitoring event, the minor landslide was not affecting any GHAD-maintained land and has remained unchanged since the previous monitoring event. The GHAD will continue to monitor this area during future monitoring events.

Minor landslide at the end of Volterra Court.

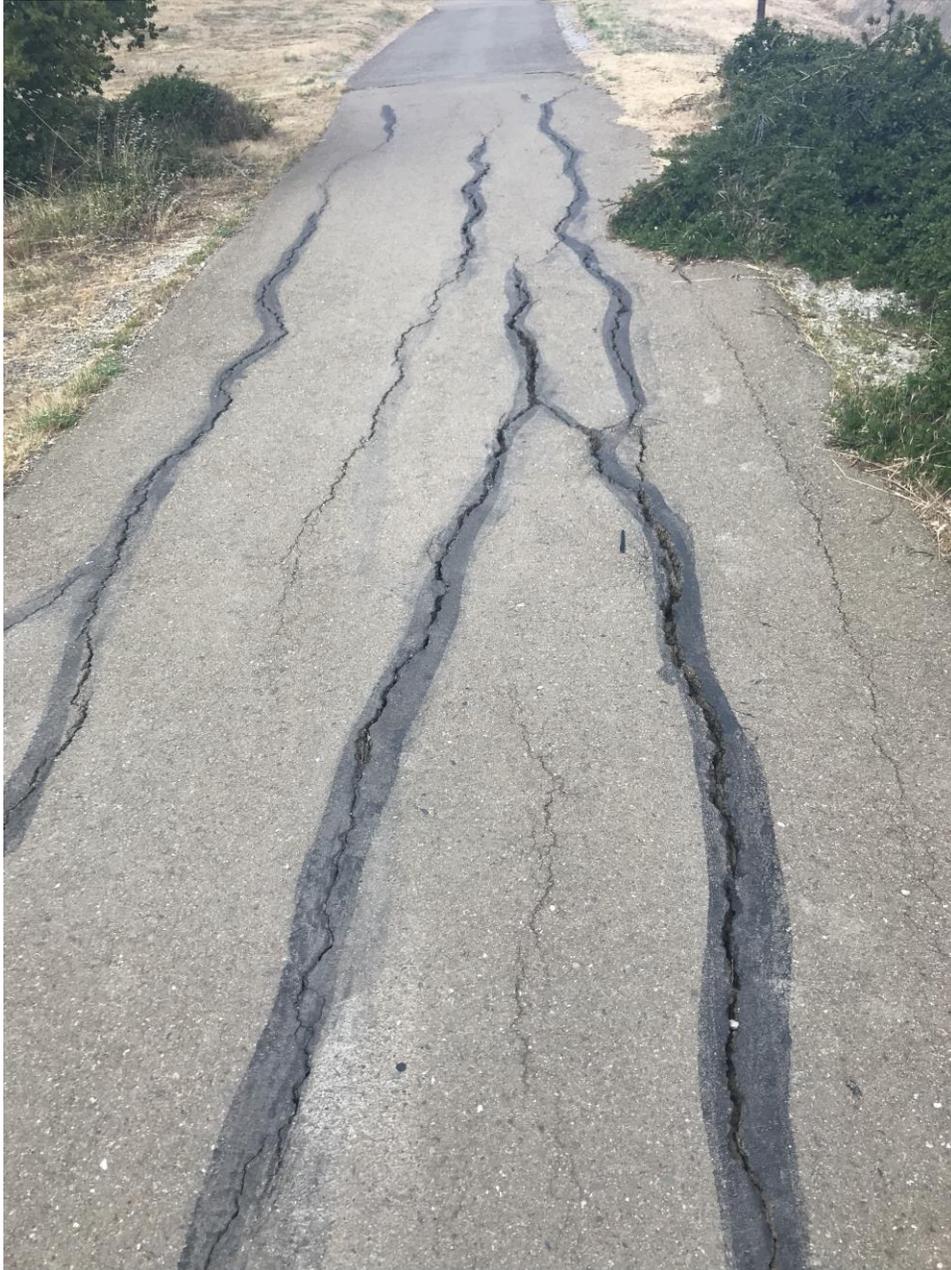
PHOTOGRAPH 5: Site Condition I

In several areas on the asphaltic concrete surfaced trails, there were lineal cracks that run parallel to the edge of the trail. Most of these cracks were relatively narrow and will be sealed or resealed as part of routine site maintenance. At the northern edge of the Jordan Ranch development, we observed cracks up to 40 feet long, 3 inches wide, and 5 inches deep allowing surface water to saturate the subgrade materials (Figure 3, Site Condition I, Photograph 5). It

appears that soil creep was causing distress to the trail surface. As a short-term solution, the cracks will be backfilled. In addition, the GHAD will evaluate longer-term mitigation measures.

Linear cracks parallel to edge of asphaltic-concrete surfaced trail.

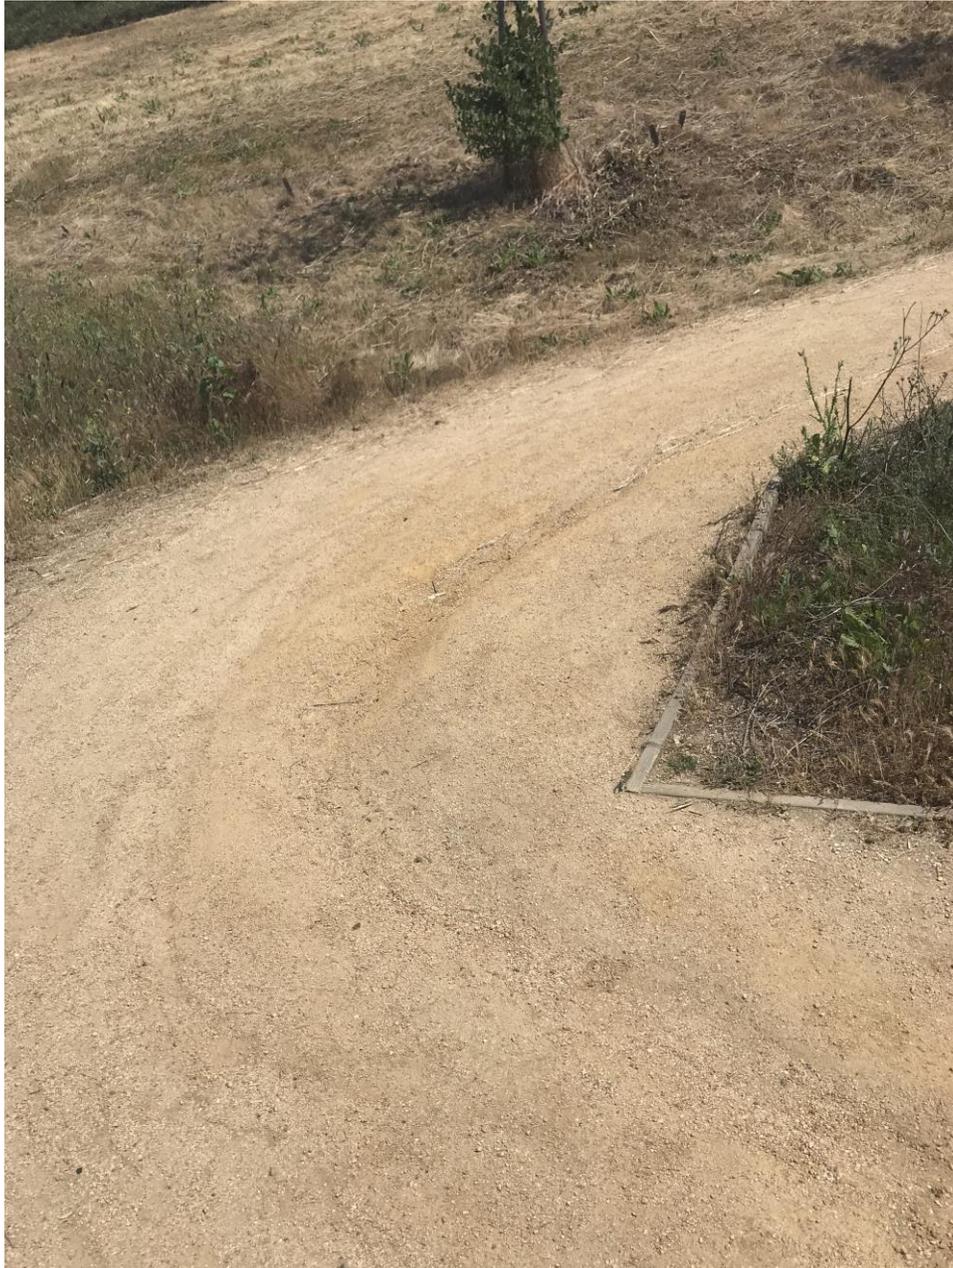
PHOTOGRAPH 6: Site Condition J

A decomposed granite-surfaced trail crosses through the creek in the Jordan Ranch development. The trail was in moderately good condition with the exception of erosion gullies at various locations on the trail (Figure 3, Site Condition J, Photograph 6). The GHAD will backfill the erosion gullies and continue to monitor the trail during future monitoring events.

Erosion along decomposed granite-surfaced trail.

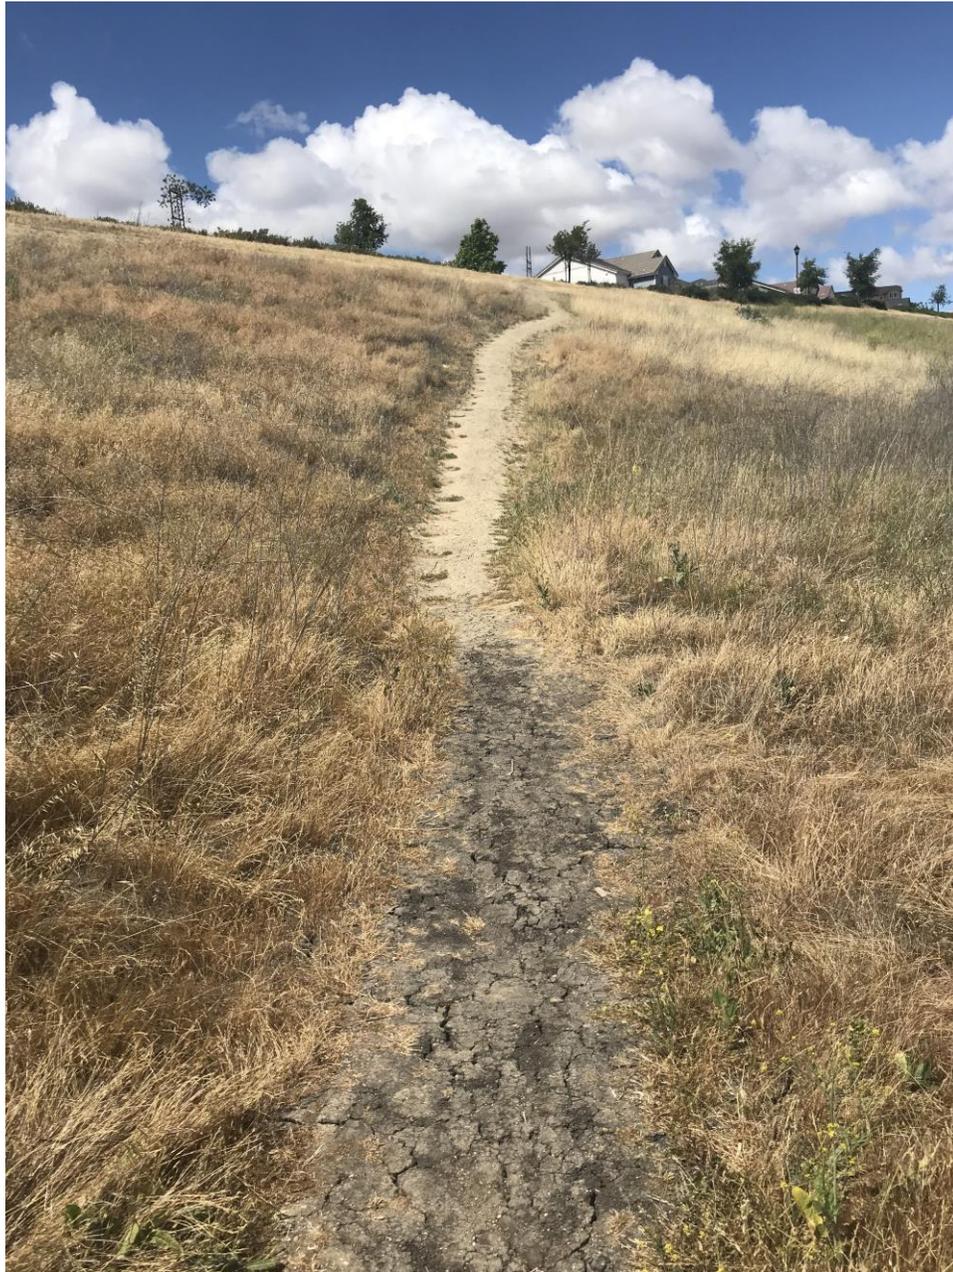
PHOTOGRAPH 7: Site Condition K

At several points adjacent to the trail, there were unauthorized paths that deviate from the designated trail (Figure 3, Site Condition K, Photograph 7). Bare soil was exposed on the unauthorized trail segments. We have not observed erosion on the unauthorized trails, but a shallow depression was observed adjacent to the trail (Figure 3, Site Condition Q, Photograph 10). The unauthorized trail segments will be monitored during future scheduled monitoring events.

Unauthorized trail used to access designated trail.

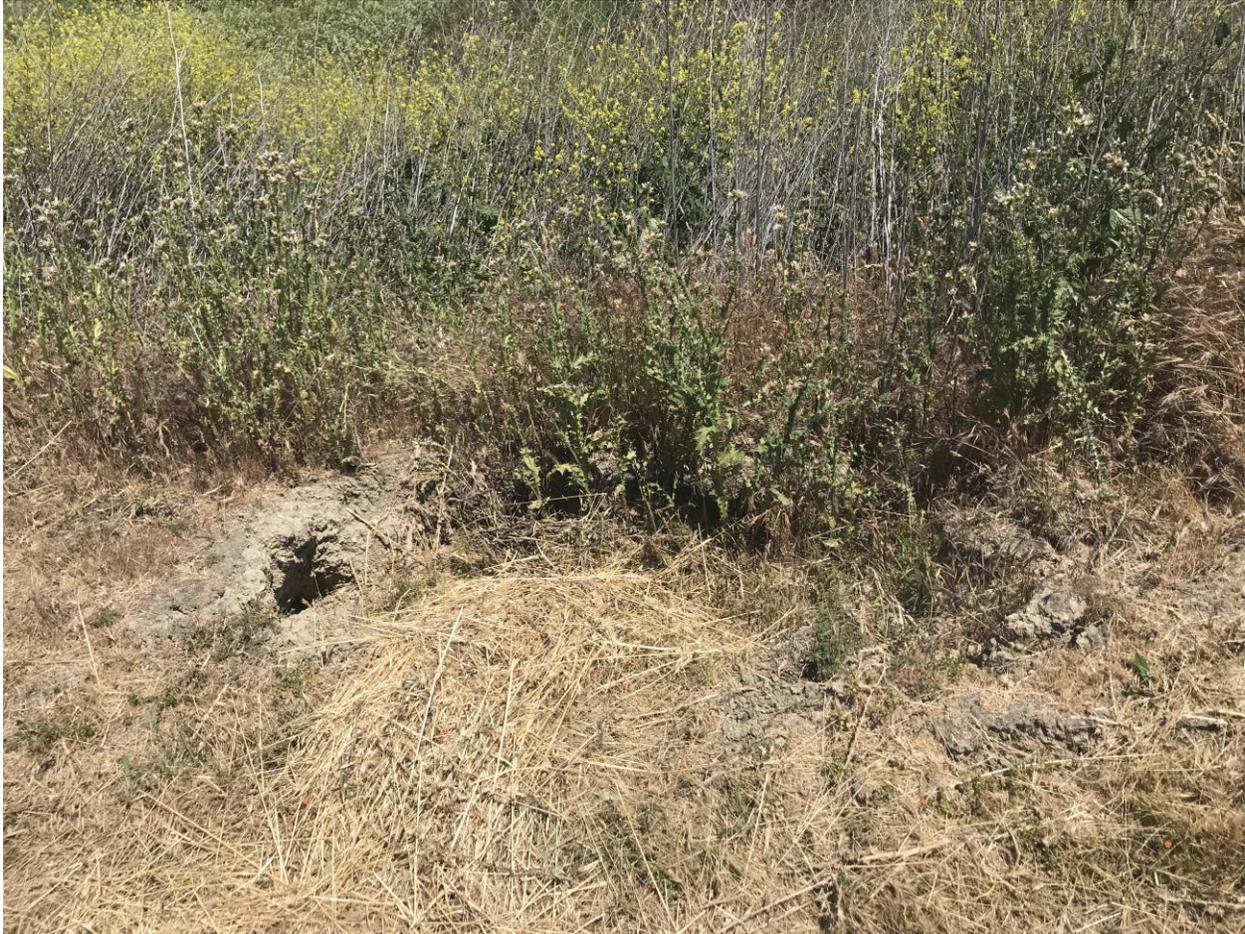
PHOTOGRAPH 9: Site Condition P

Depression due to animal burrowing along footpath next to school.

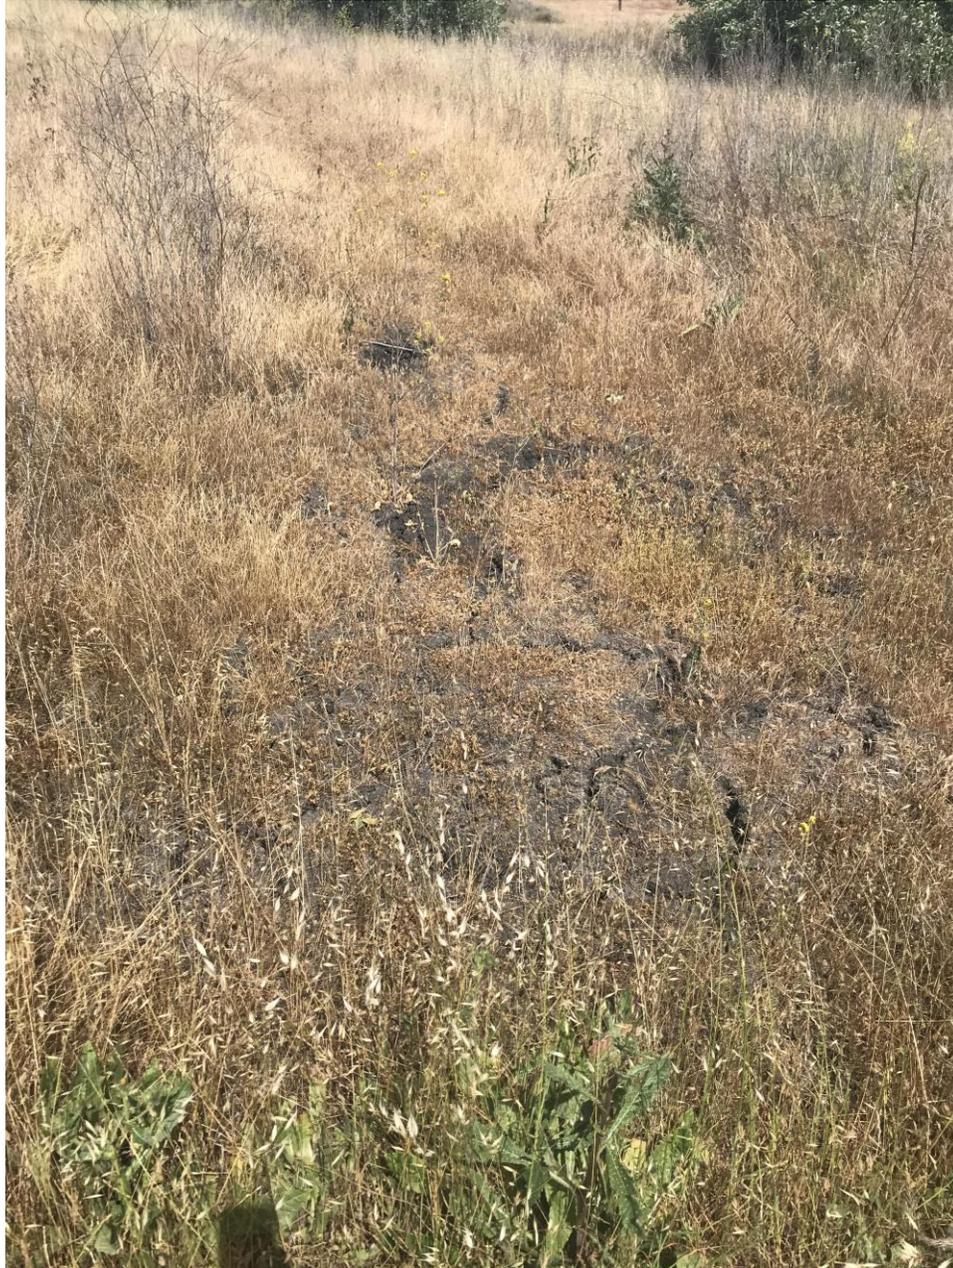
PHOTOGRAPH 10: Site Condition Q

Depression adjacent to foot path in Jordan Ranch development.

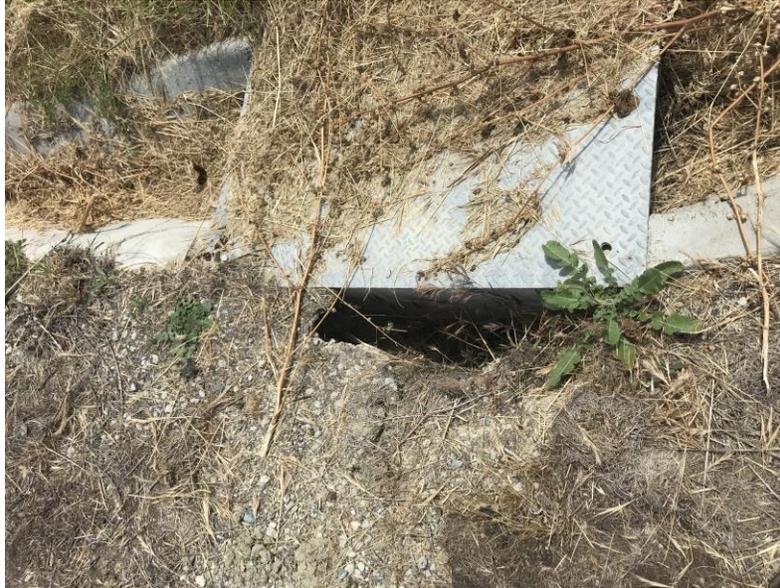
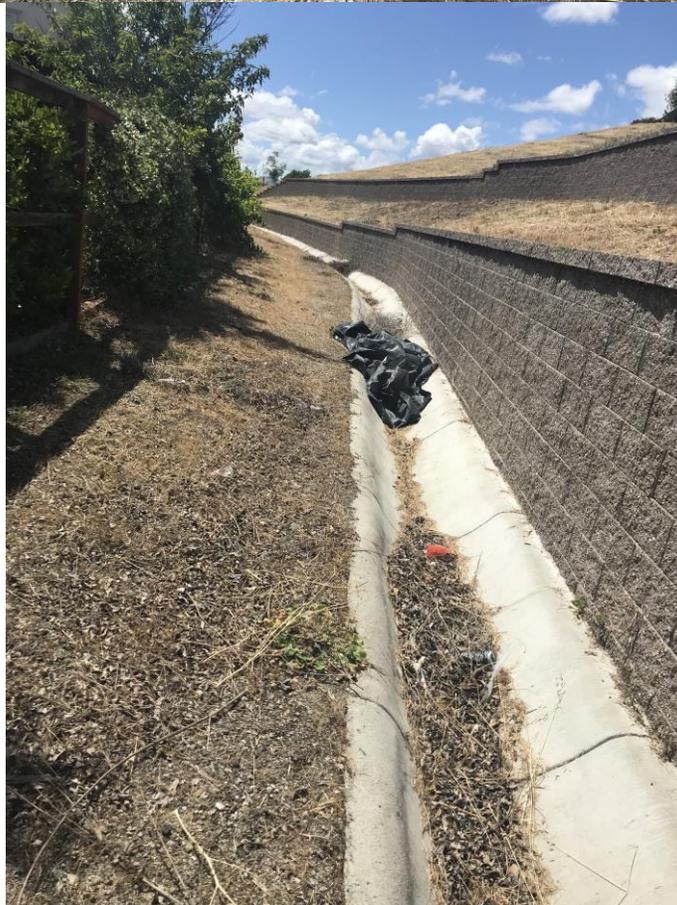
PHOTOGRAPHS 11 and 12: Site Conditions R and S

Grass clippings, leaves, and debris in concrete-lined drainage ditch.

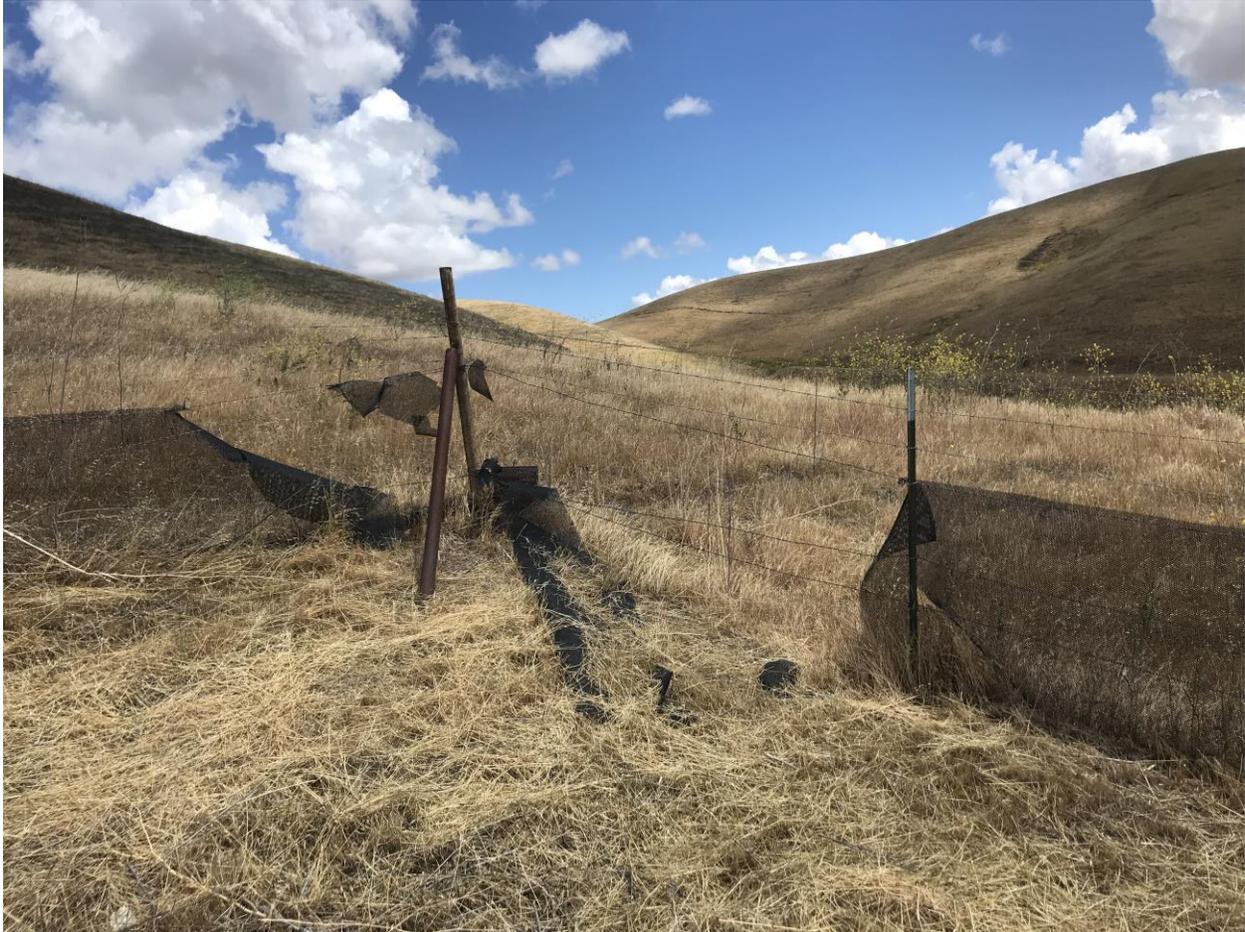
PHOTOGRAPH 13: Site Condition T

Fences, locks, and signage within the GHAD were observed for loss or damage. Locks and signage were in good condition and will be replaced as necessary. We noted that there were some segments where the wildlife fencing along the open space boundary has been damaged (Figure 2, Site Condition T, Photograph 13). The GHAD will repair or cause to be repaired the fencing as necessary.

Wildlife fencing damaged at the end of Castello Court.

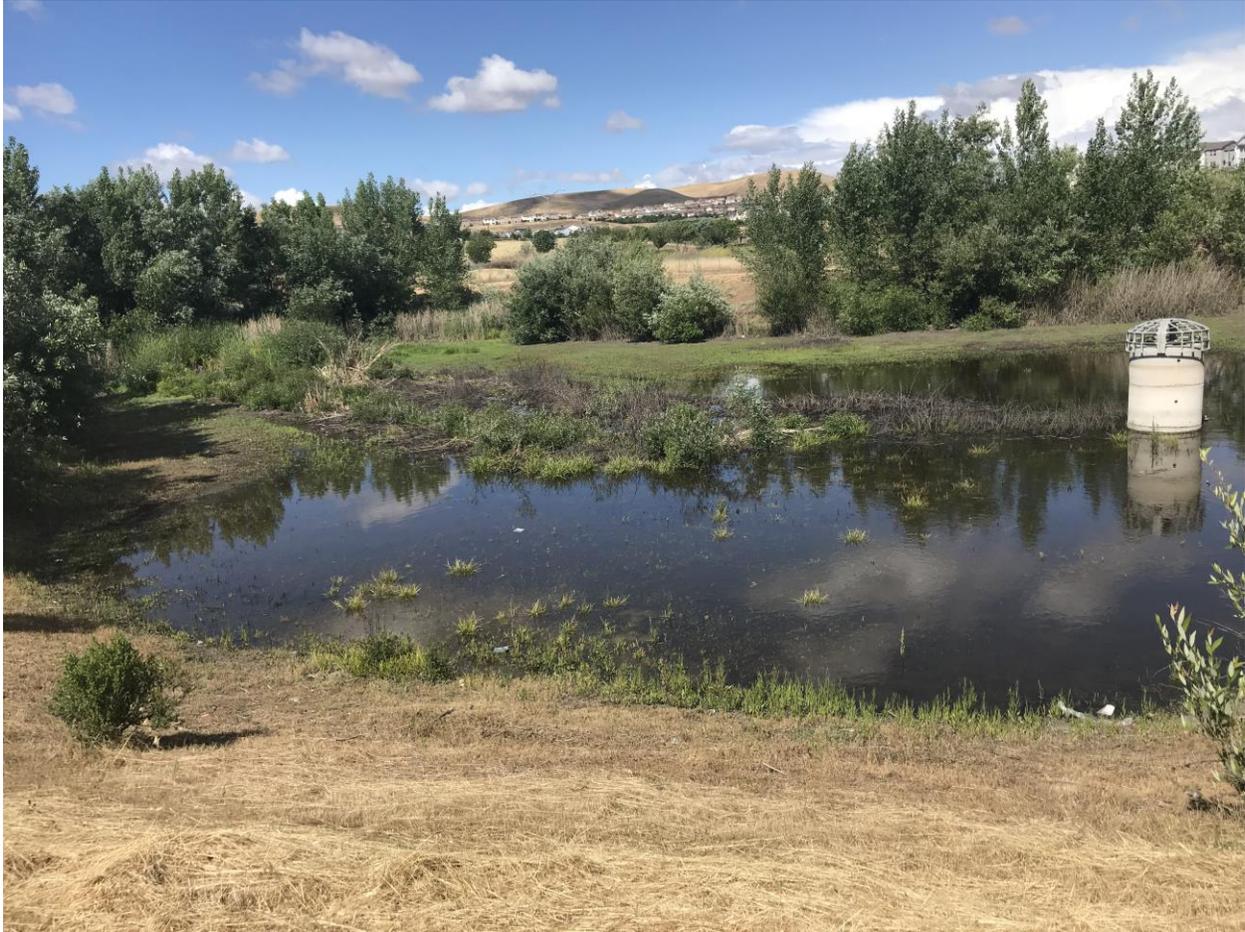
PHOTOGRAPH 14: Site Condition M

During the fall 2017 monitoring event, standing water was observed within the water quality basin in the Jordan Ranch development (Figure 3, Site Condition M, Photograph 14). Clayey sediments deposited on top of the filter medium prevented water from infiltrating properly. In March 2018, the GHAD performed a temporary repair by pumping the standing water out of the basin, excavating clayey material adjacent to the outfall structure, exposing the existing subdrain and backfilling the excavation with riprap to allow water to drain properly. A permanent repair involving removal of the clayey materials and the upper portion of the filter medium has been scheduled in 2020. At the time of our most recent monitoring, standing water was present within the water quality basin. A permanent repair will be necessary to remove the water and restore proper function to the basin.

Standing water within water quality basin.

Standing water should be removed and sediment cleared to allow proper drainage. A permanent repair involving removal of clayey sediments and replacing the filter medium has been scheduled in 2020.
