Project No.
4748.002.019

June 24, 2020

Subject: Schaefer Ranch Development
Dublin, California

GEOLOGIC HAZARD ABATEMENT DISTRICT MONITORING – SPRING 2020

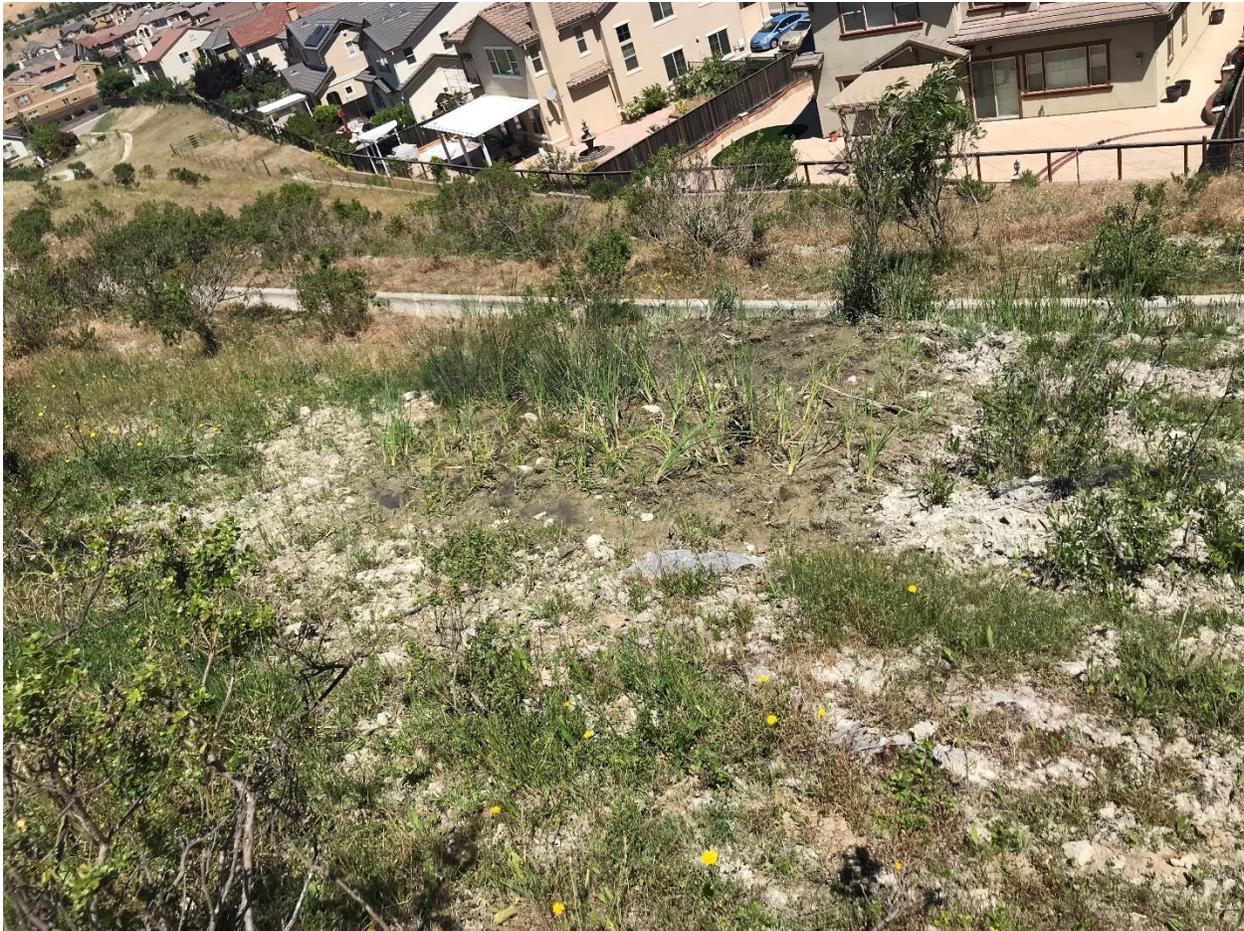
PHOTO 1: Site Condition A.

Evidence of previous saturation of soil was observed in this area in the open space south of Ridgeline Drive. At the time of the visit, the area was saturated with water tolerant vegetation and ponded water in the concrete-lined ditch (Figure 2, Site Condition A, Photograph 1). The slope adjacent to the seep appears to be performing well.

Seep with standing water and vegetation above concrete-lined drainage ditch.

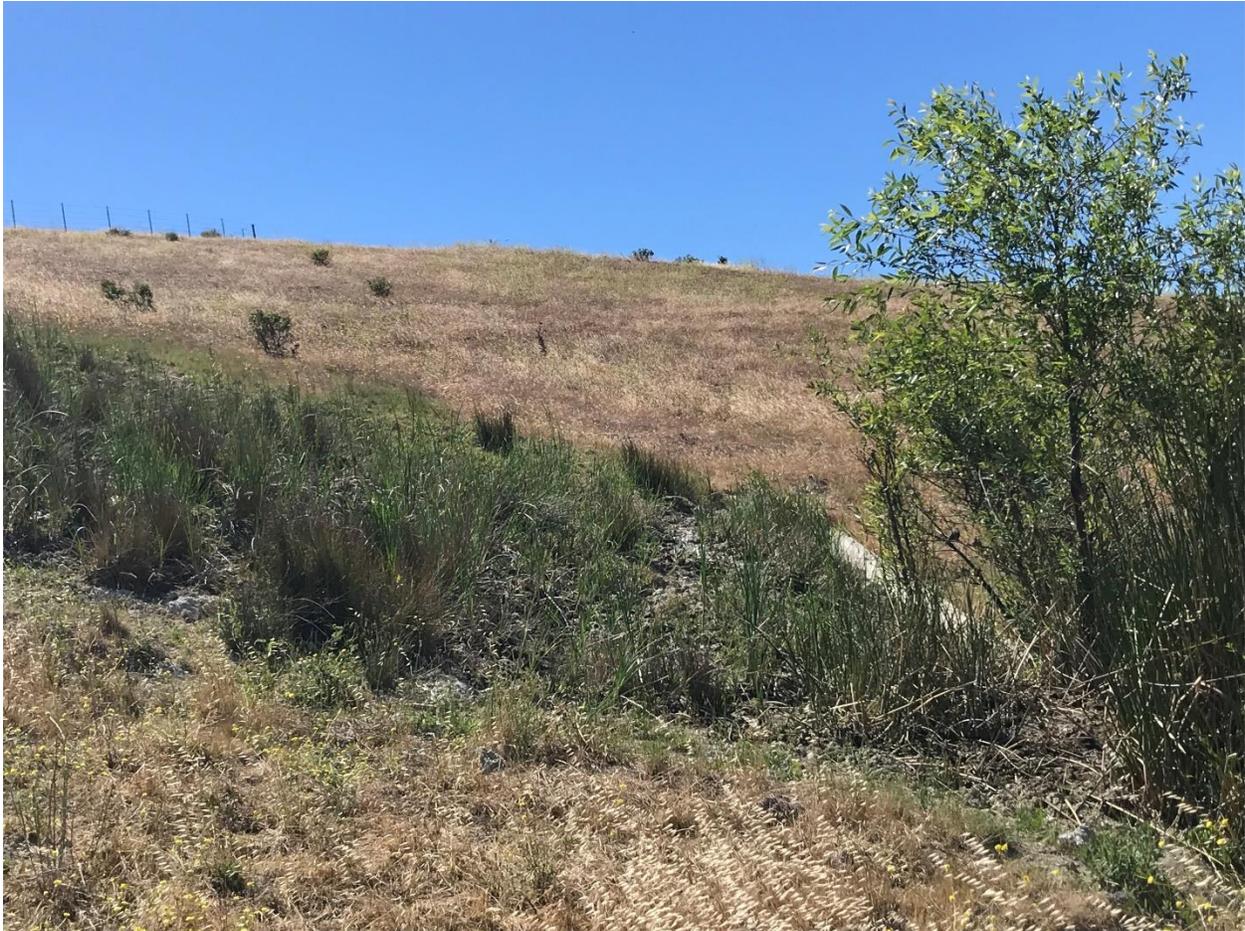
PHOTO 2: Site Condition B.

A significant seep was located northeast of Marshall Canyon Court (Figure 2, Site Condition B, Photograph 2). This seep appears to have been active since grading was completed in this area in 2007 (Reference 3). As part of the mass grading, Subdrain SD-40 was installed in this area and the outlet is located in a storm drain inlet on Marshall Canyon Court. The slope remains highly saturated with moisture-tolerant vegetation. The slope did not appear to display signs of significant movement, and a gravel surface access road is situated between the slope and the houses. A significant amount of sediment has been deposited in the concrete-lined drainage ditch downslope of the seep. The GHAD will schedule removal of the sediment and clearing of vegetation adjacent to the ditch.

Seep with continuous flow on to slope east of Marshall Canyon Court.

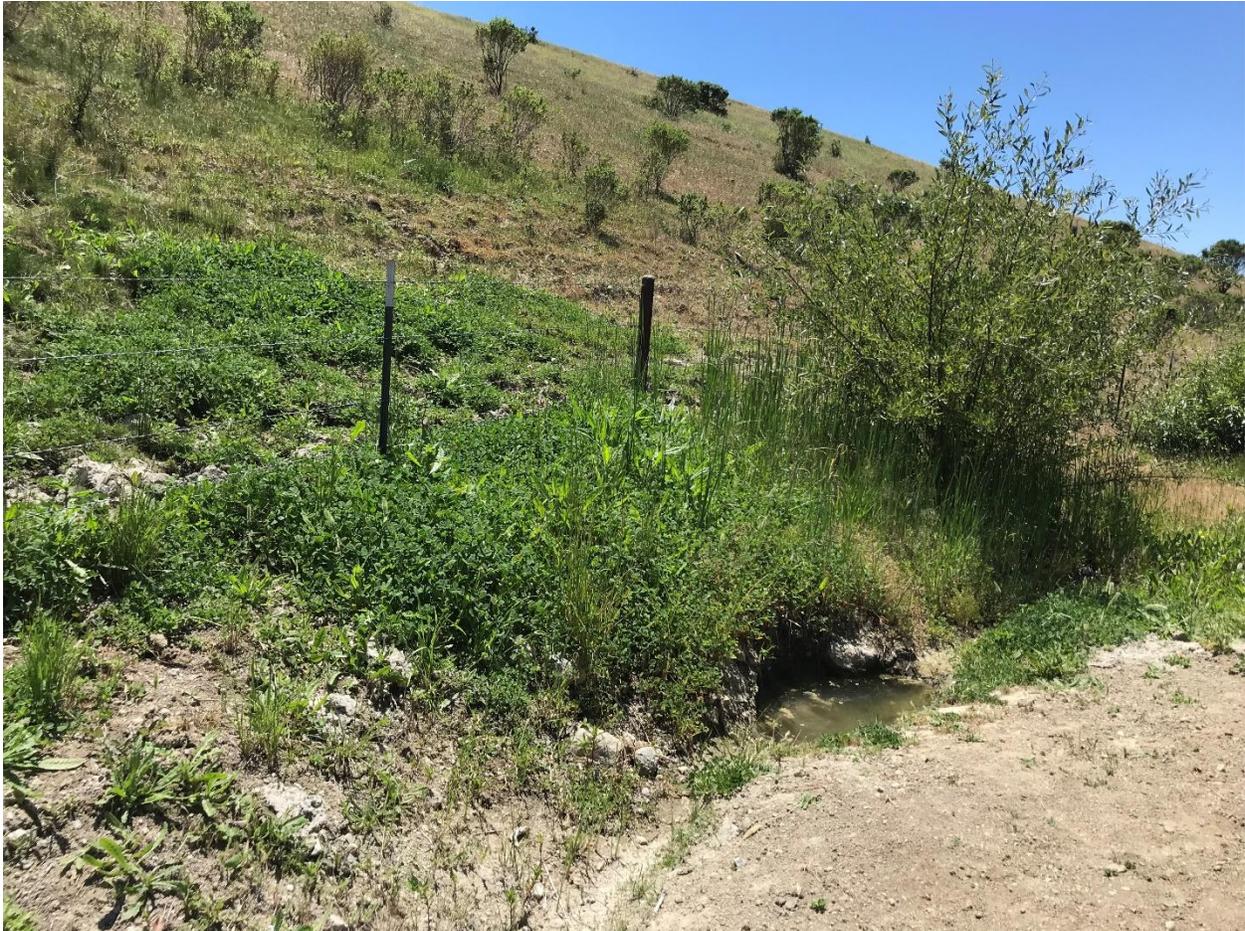
PHOTO 3: Site Condition C.

A seep south of 10138 Lilly Pad Court, which has been periodically monitored and showed signs of increased flow and animal rooting (Figure 2, Site Condition C, Photograph 3). A small depression has developed at the base of the seep within the debris bench and it has filled with water from the seep. The GHAD will fill the depression and continue monitoring this area.

Seep with ponded water south of 10138 Lilly Pad Lake Court.

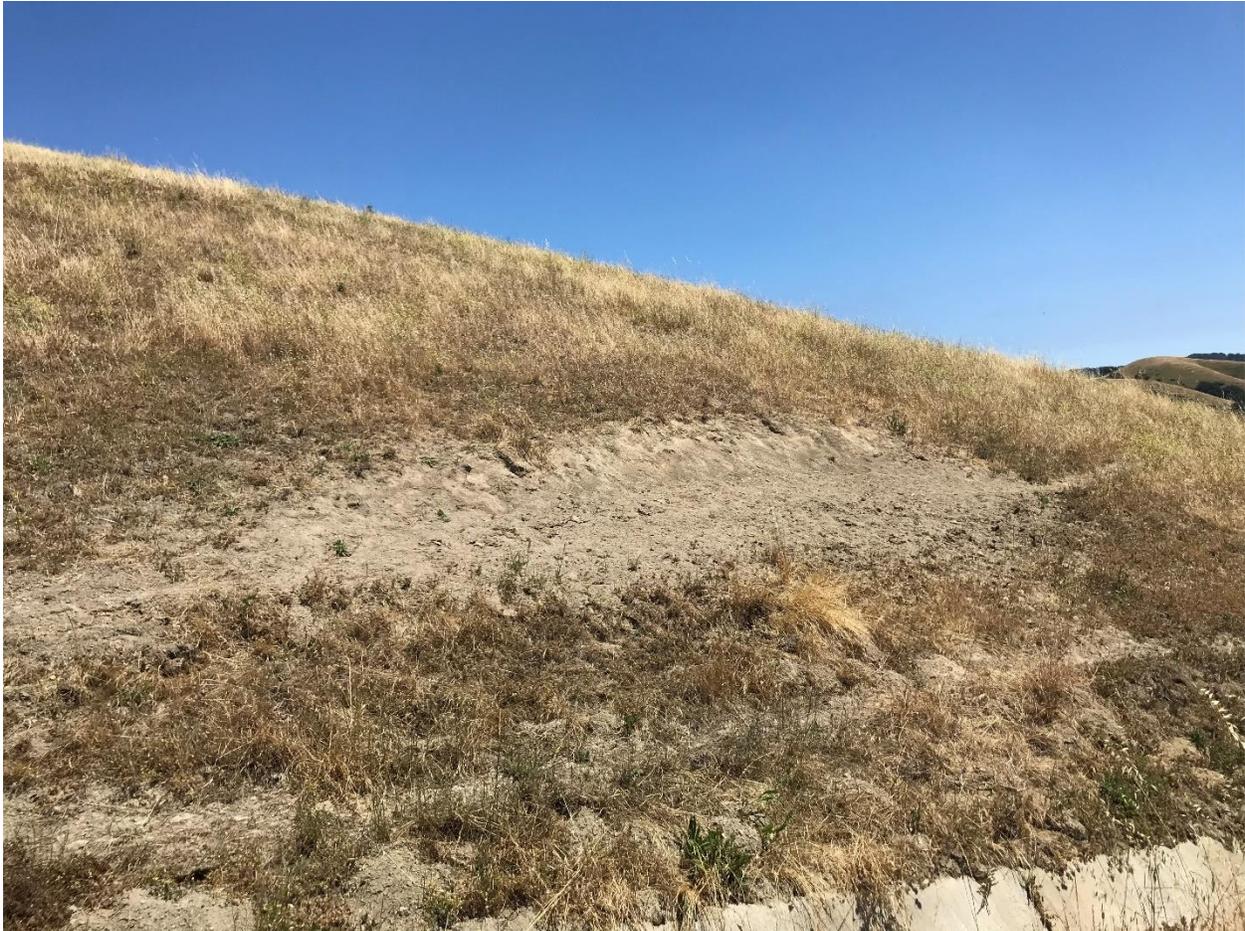
PHOTO 4: Site Condition F.

Erosion, in the form of rills, etc., was observed in various locations around the property (Figure 2, Site Condition F). Specifically, on the slope east of the beginning of the trail at the Donlon Point Staging Area, there is erosion exposing bare soils, possibly due to animal grazing paths or shallow bedrock (Photograph 4). In general, the erosional features were relatively minor; however, erosion can create a positive feedback loop in which erosion leads to further erosion. These areas will continue to be monitored, and as needed, erosional slopes will be repaired as a part of regular GHAD maintenance.

Bare soils exposed north of trailhead at Donlon Point Staging Area.

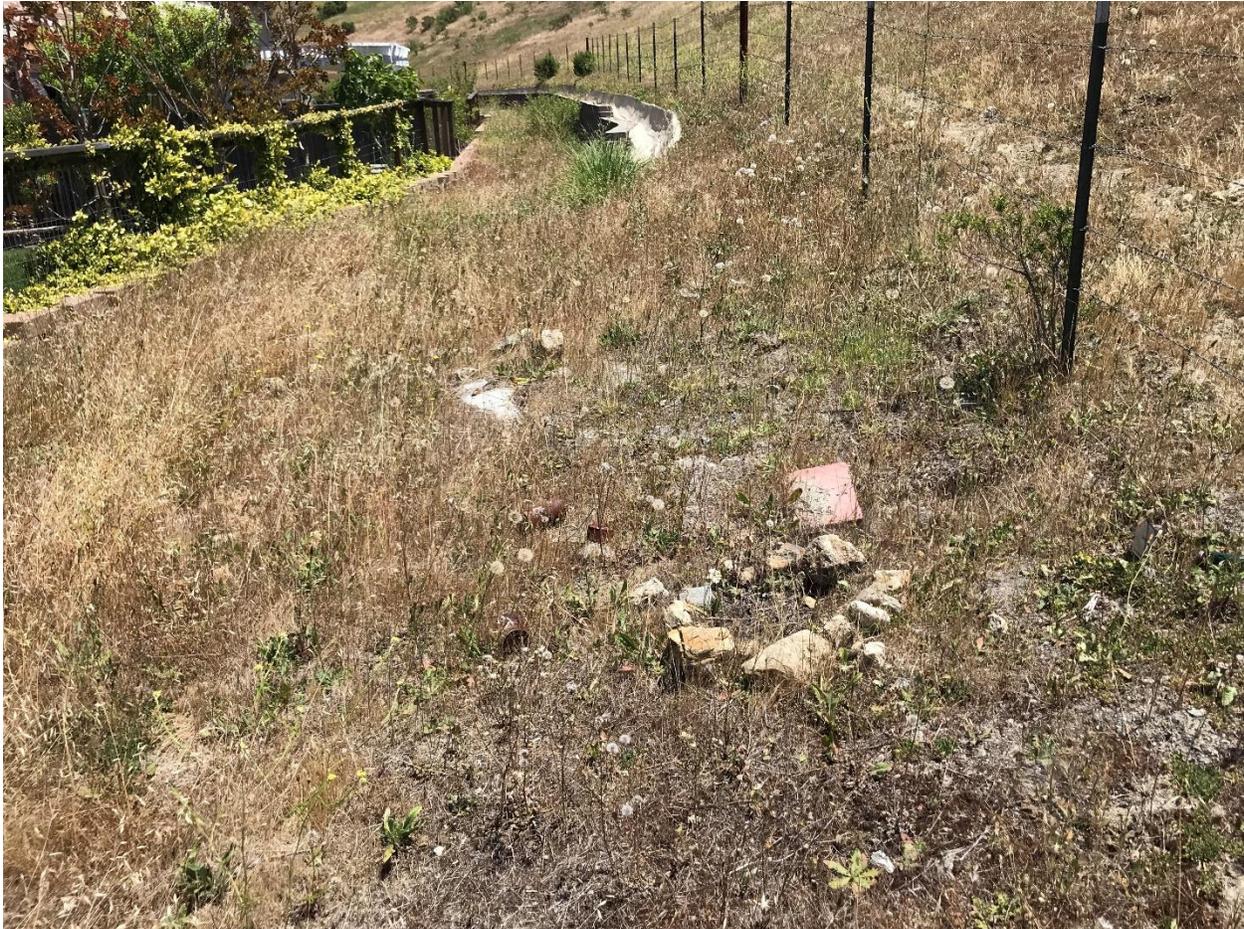
PHOTO 5: Site Condition G.

A fire pit and some litter were observed during the spring monitoring event within the open space south of 7639 Ridgeline Drive and south of 10138 Lilly Pad Lake Court (Figure 2, Site Condition G, Photographs 5 and 6). Homeowner and human activity on GHAD-owned land in undesignated areas is not allowed; therefore, the GHAD will has removed these materials.

Signs of previous human activity within GHAD-owned open space within conservation easement south of 7639 Ridgeline Drive.

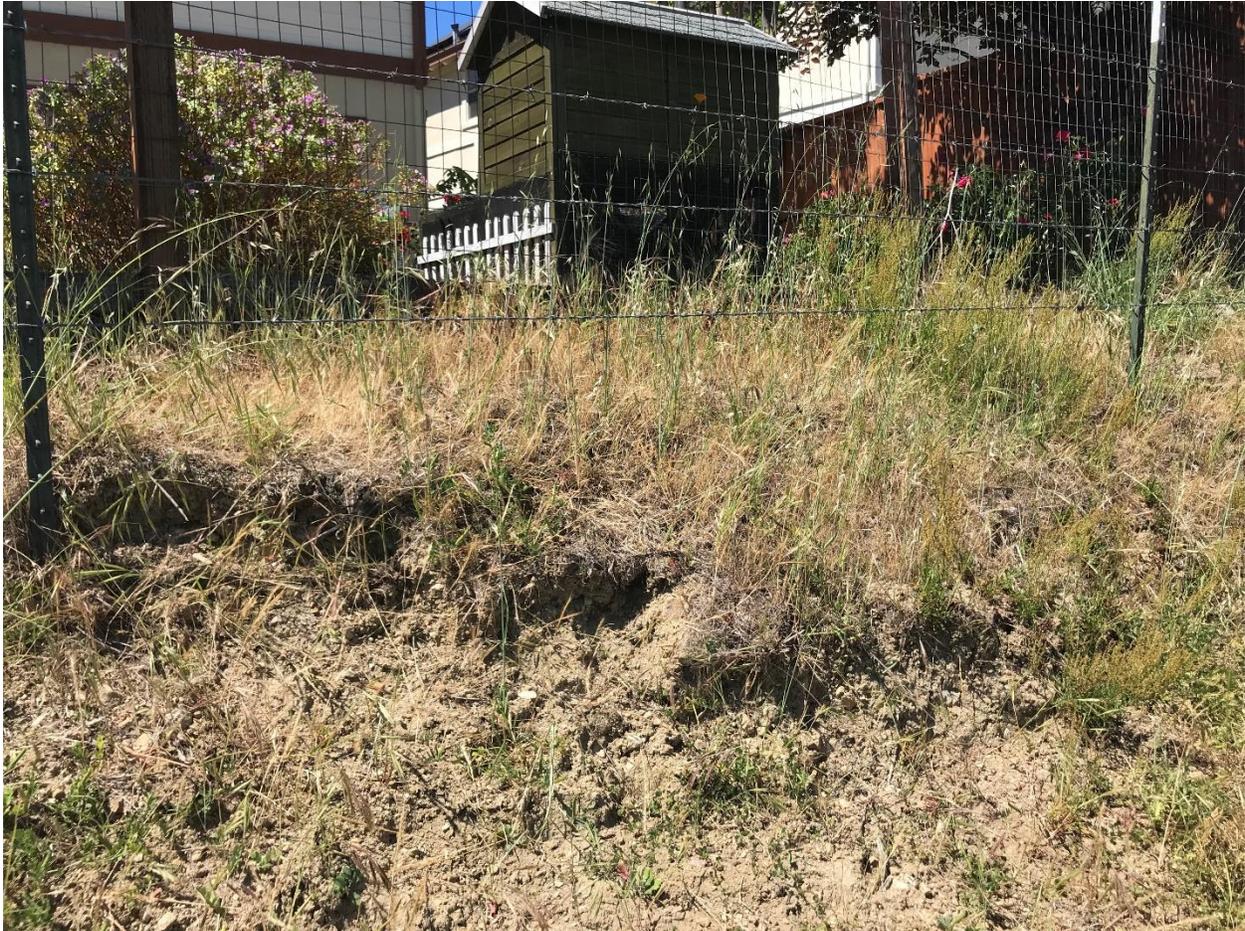
PHOTO 6: Site Condition H.

Erosion and a minor failure with a scarp measuring approximately 6 feet wide has formed at the back of 9779 Reimer Way downslope of the barbed-wire behind the property (Figure 2, Site Condition H, Photograph 6). The soil loss does not appear to be impacting the nearby improvements but we will continue to monitor the area for signs of further de-stabilization of the slope.

Shallow slope failure below barbed-wire fence downslope of 9779 Reimers Way.

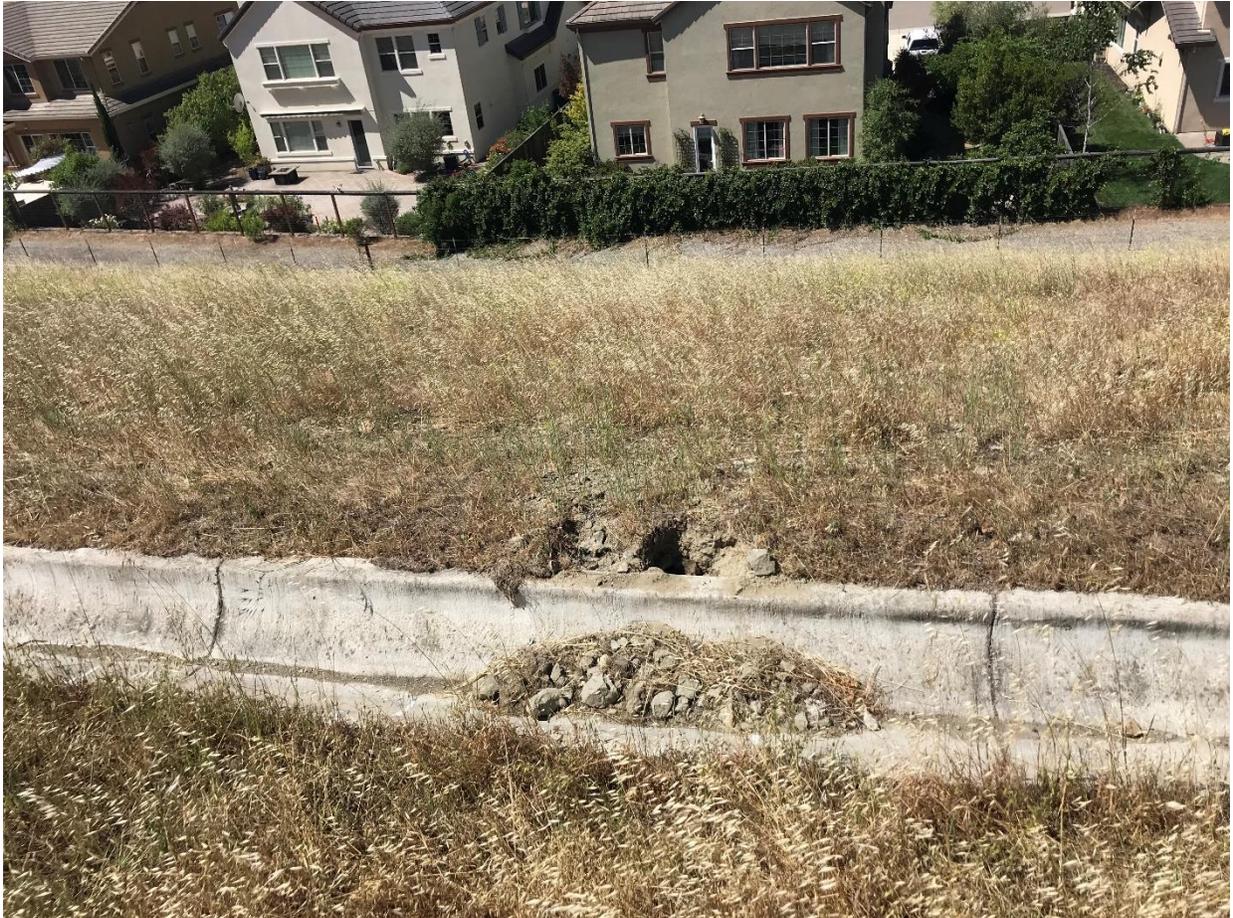
PHOTO 7: Site Condition I.

A burrow has been excavated adjacent to the concrete-lined drainage ditch (Figure 2, Site Condition I, Photograph 7). The concrete-lined drainage ditch did not appear to be distressed at the time of our recent monitoring; however, these voids may allow water to infiltrate underneath the concrete-drainage ditch and cause distress. We will fill the animal burrows as needed to protect support for the concrete-lined drainage ditch.

Burrow beside concrete-lined drainage ditch

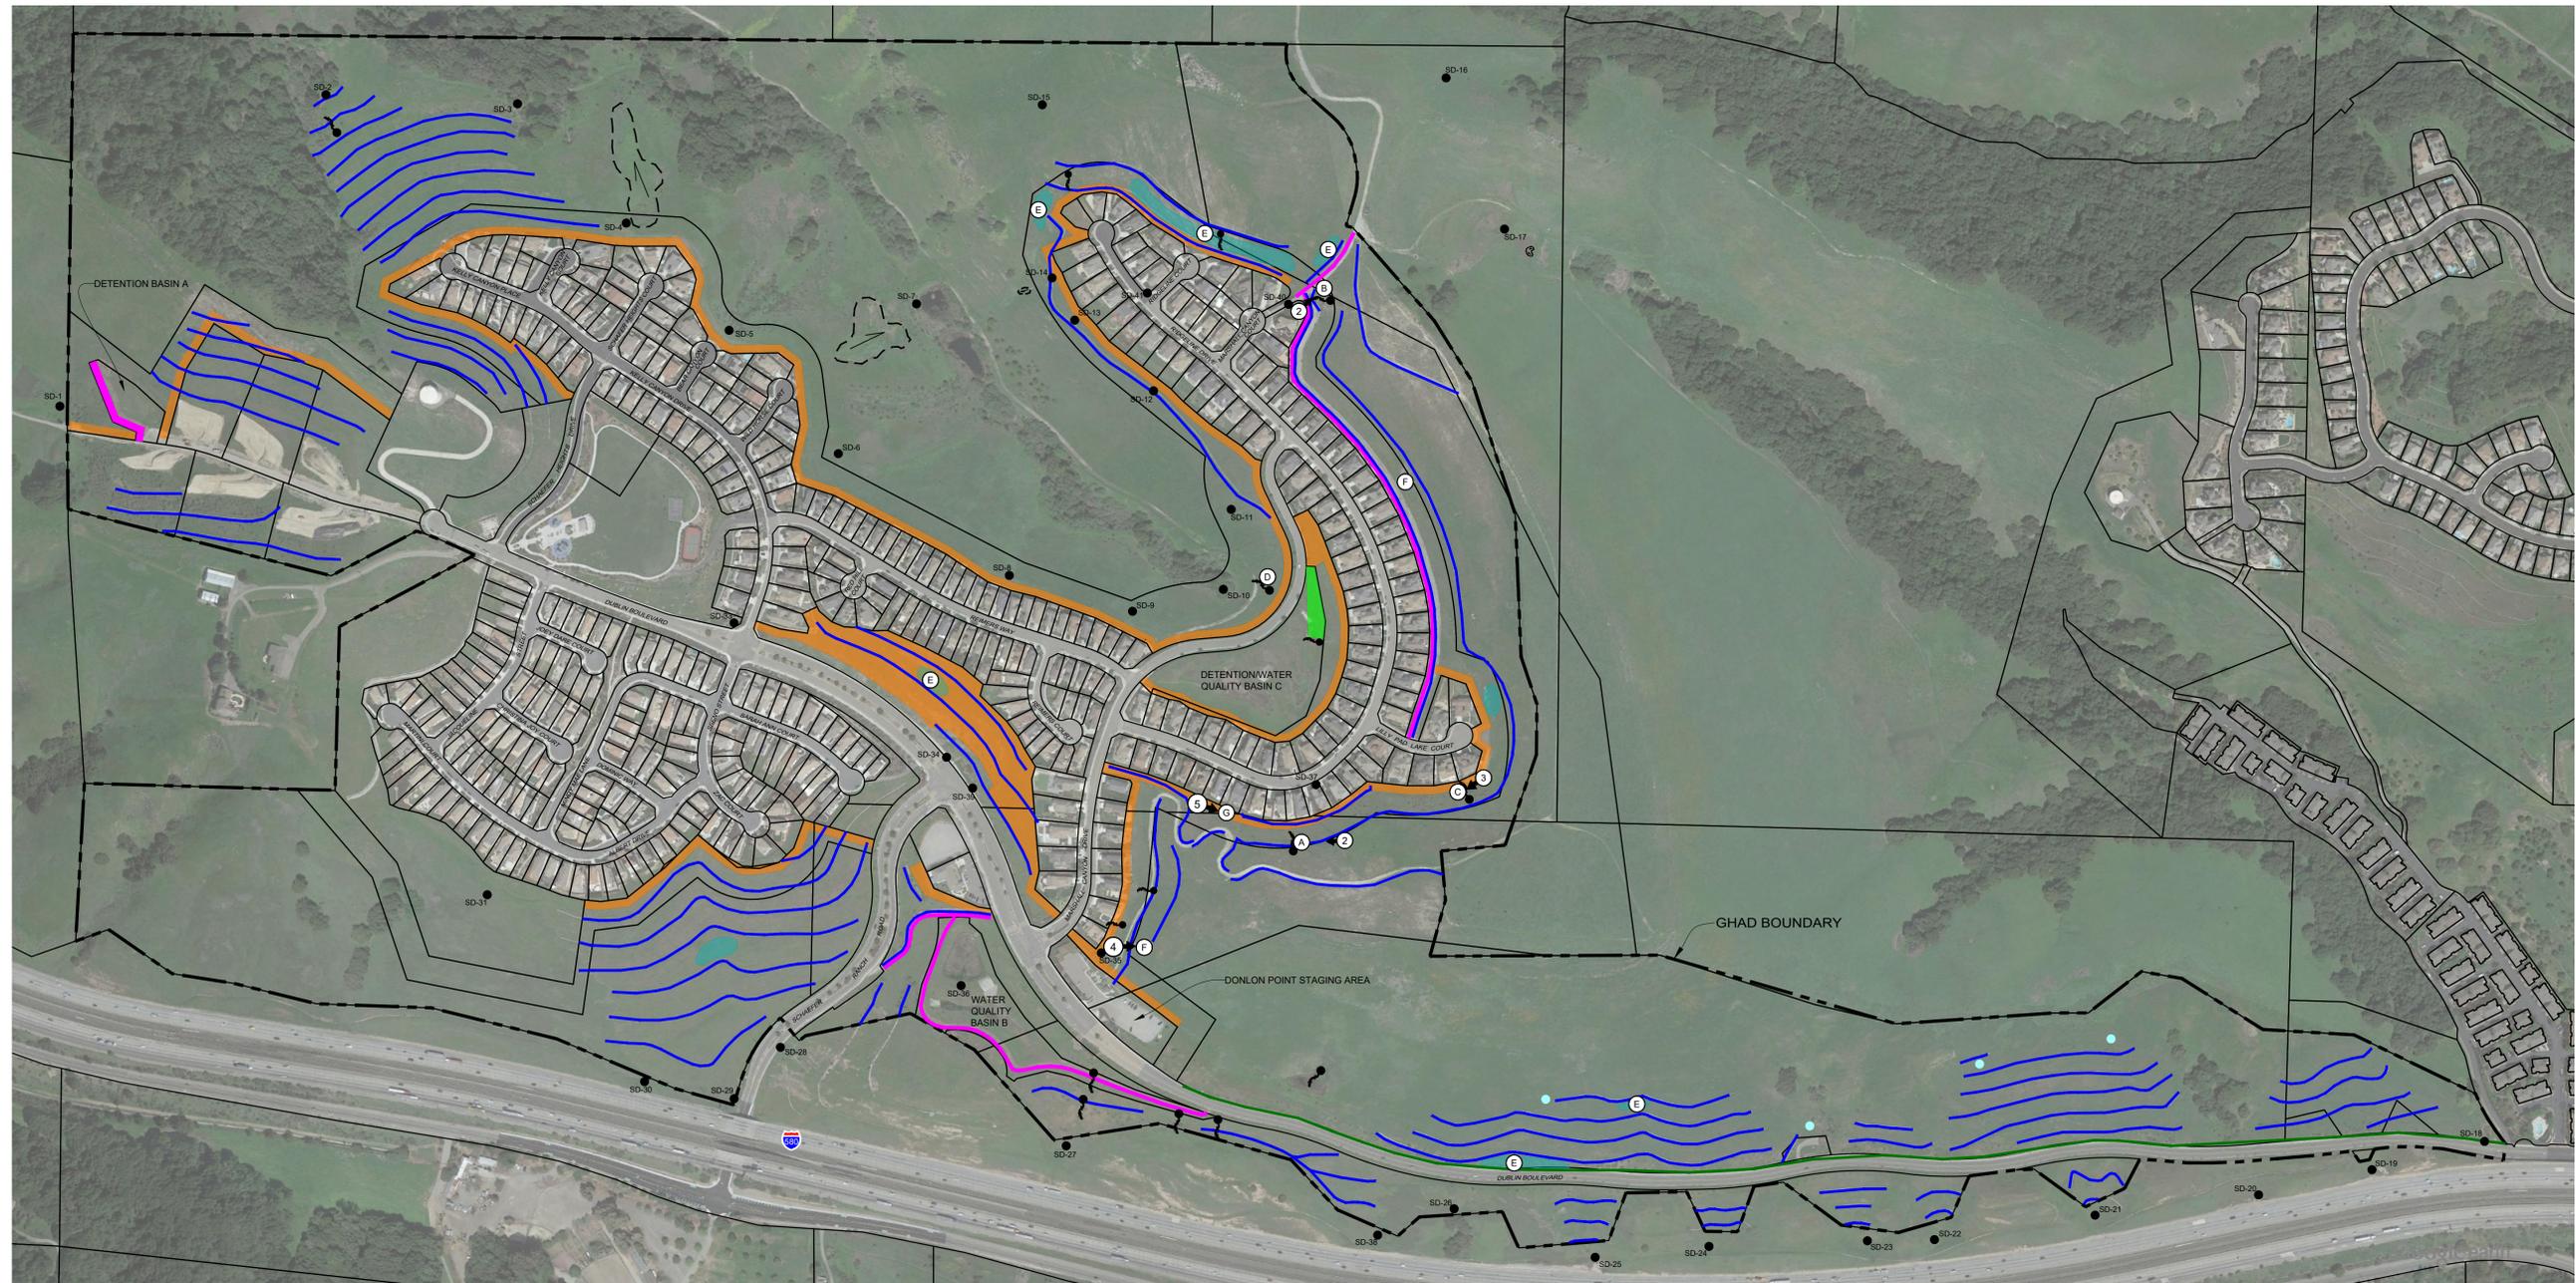
Seeps were observed in a number of locations as shown on Figure 2. No indications of slope instability was associated with the seeps. However, saturated soils significantly reduce the slope stability and performance over time and can lead to failures. The GHAD will continue to monitor the slope areas with seeps for indications of slope instability and provide additional subsurface drainage as slope conditions warrant.

There is evidence of a minor seep northwest of Marshall Canyon Drive. At the time of our most recent monitoring event, the seep appeared to be dry. This area will continue to be monitored during future visits (Figure 2, Site Condition D).

There are several areas with dense concentrations of animal burrows (Figure 2, Site Condition E). Burrows allow for the rapid infiltration of water into the near-surface soil, which can cause the loss of cohesion and lead to unstable slope conditions. The GHAD will consider burrowing animal population control if we identify signs of slope instability in accordance with the requirements of the Final Mitigation and Monitoring Plan and Perpetual Conservation Easement Deed (References 5 and 6).
