ENGEOTM INCORPORATED, GHAD Consultant

June 28, 2024

Subject: Jordan Ranch and Positano Developments
Dublin, California

GEOLOGIC HAZARD ABATEMENT DISTRICT MONITORING SPRING 2024

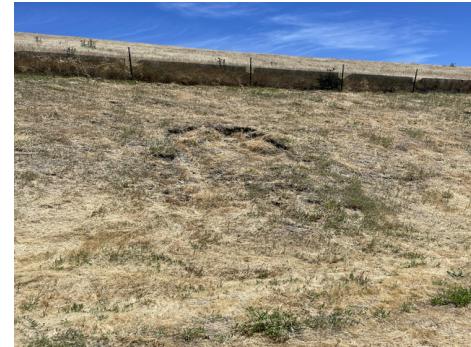
Site Condition: A
Observation Date: 05/30/2024

During fall 2023, a surficial slope failure measuring approximately 6 feet in width, 10 feet in length, and 1 foot in depth was observed east of N Terracina Drive. During this monitoring event, the slope failure appeared to be unchanged and partially vegetated (Site Condition A, Appendix A, Figure 2). The GHAD will continue to monitor this condition and repair the slope failure, if needed.

Description: Surficial earthflow.

Recommendation: Continue to monitor.

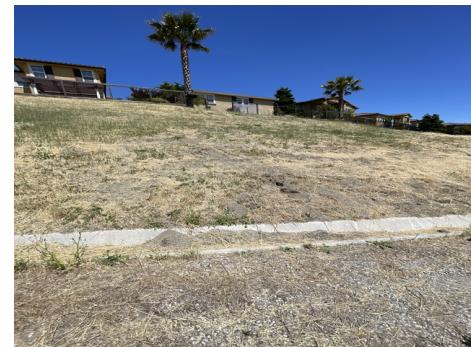
Site Condition: B.1
Observation Date: 05/30/2024

During our site visit, we observed several areas with surficial erosion to the slopes adjacent to the site improvements (Site Conditions B.1 through B.5, Appendix A, Figure 2). These areas will continue to be monitored during future monitoring events.

Description: Surficial slope erosion.

Recommendation: Continue to monitor.

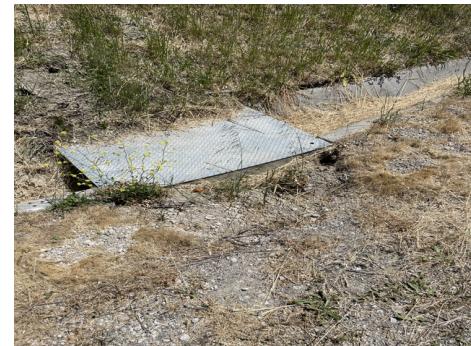
Site Condition: B.2
Observation Date: 05/30/2024

Description: Surficial slope erosion.

Recommendation: Continue to monitor.

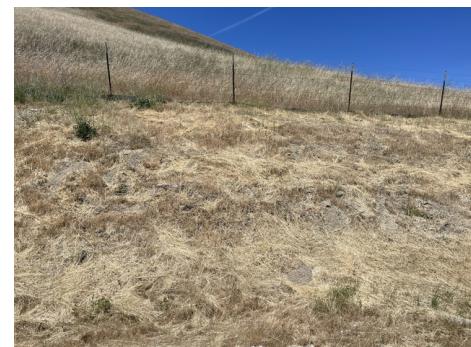
Site Condition: B.3
Observation Date: 05/30/2024

Description: Surficial slope erosion.

Recommendation: Continue to monitor.

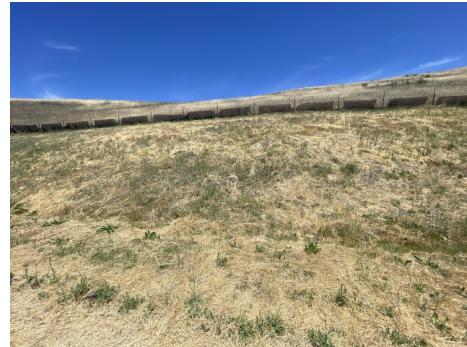
Site Condition: B.4
Observation Date: 05/30/2024
Description: Surficial slope erosion.

Recommendation: Continue to monitor.

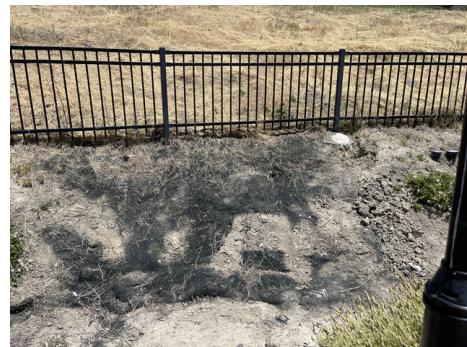
Site Condition: B.5
Observation Date: 05/30/2024
Description: Surficial slope erosion.

Recommendation: Continue to monitor.

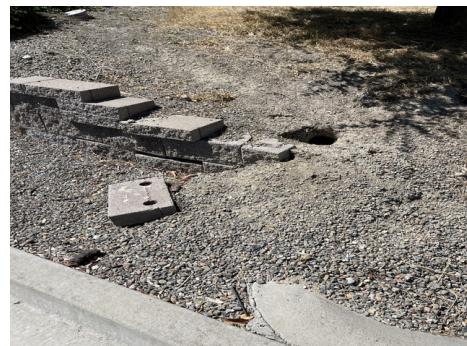
Animal burrows were observed during this monitoring event at various locations across the site (Figures 2 and 3). In some locations, the burrowing activity has deposited soil into the earthen- and concrete-lined ditches (Site Conditions C.1 and C.2, Appendix A, Figures 2 and 3). The deposited soil should be removed as part of annual maintenance.

Site Condition: C.1
Observation Date: 05/30/2024
Description: Animal burrowing.

Recommendation: Continue to monitor.

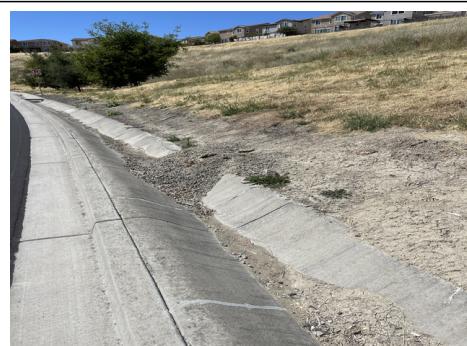
Site Condition: C.2
Observation Date: 05/30/2024
Description: Animal burrowing.

Recommendation: Continue to monitor.

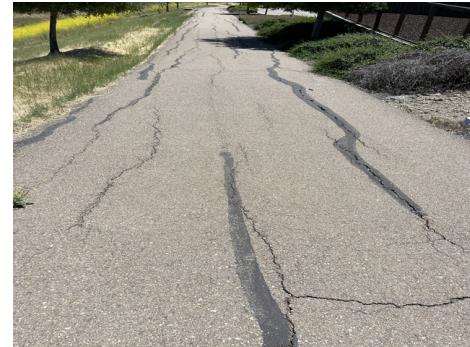
Site Condition: D.1
Observation Date: 05/30/2024

Since fall 2018 and spring 2022, we have observed and noted the presence of cracks on the asphalt-paved trail that transects both the Positano and Jordan Ranch developments. Most of these cracks are narrow with some cracks that measure up to 40 feet long, 3 inches wide, and 5 inches deep. During the recent site monitoring event, we observed the cracking to be relatively unchanged (Site Conditions D.1 through D.3). It appears that expansive soils and soil creep are the possible causes of the distress to the trail surface. As a short-term solution, the cracks will be sealed or resealed as part of routine site maintenance.

Description: Distress cracking within asphaltic concrete trail.

Recommendation: Seal/reseal, as needed.

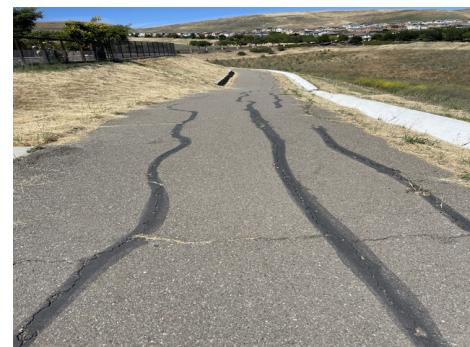
Site Condition: D.2
Observation Date: 05/30/2024

Description: Distress cracking within asphaltic concrete trail.

Recommendation: Seal/reseal, as needed.

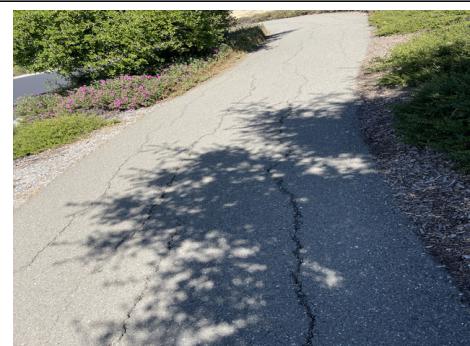
Site Condition: D.3
Observation Date: 05/30/2024

Description: Distress cracking within asphaltic concrete trail.

Recommendation: Seal/reseal, as needed.

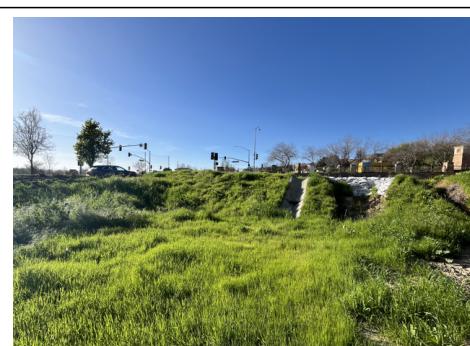
Site Condition: E
Observation Date: 05/30/2024

A berm located in Bioretention Cell 2 failed during the heavy rain event in December 2022 and January 2023 (Site Condition E, Appendix A). The berm failure is approximately 4 feet in width, 3 feet in height, and 10 feet in length. The failure has resulted in a decreased capacity of the bioretention cell. A temporary repair has been implemented but the berm should be permanently repaired with engineered fill and excess soil removed to ensure design capacity is maintained.

A failure of the upper retention berm occurred during heavy rainfall in December/January 2023. The failure measures approximately 3 feet wide and 2 feet in depth. The failure deposited sediment into the lower portion of the bioretention facility. The failure continued to erode over the Winter 2024 and continues to be exposed.

Sediment deposited on surface of facility from berm failure.

Description: Bioretention cell berm failure.

We recommend an earthwork repair with geo-grid reinforcement to restore the functionality of the basin.

We recommend removing the sediment and replacing the filter medium as needed.

Recommendation: Earthwork repair with geo-grid to reinforce berm.
