April 29, 2025

Subject: Jordan Ranch and Positano Developments
Dublin, California

GEOLOGIC HAZARD ABATEMENT DISTRICT MONITORING SPRING 2025

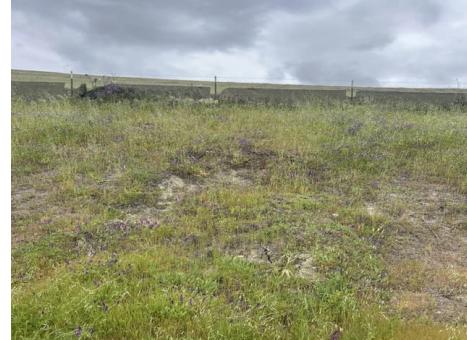
During our monitoring event in the fall of 2023, a surficial slope failure measuring approximately 6 feet in width, 10 feet in length, and 1 foot in depth was observed east of N. Terracina Drive. During this monitoring event, the slope failure appeared to be fully vegetated and unchanged in dimension (Site Condition A, Appendix A, Figure 2). The GHAD will continue to monitor this condition and repair the slope failure, if needed.

Site Condition: A
Observation Date: 04/17/2025
Description: Surficial earthflow.

Recommendation: Continue to monitor.
Field Representative: EW

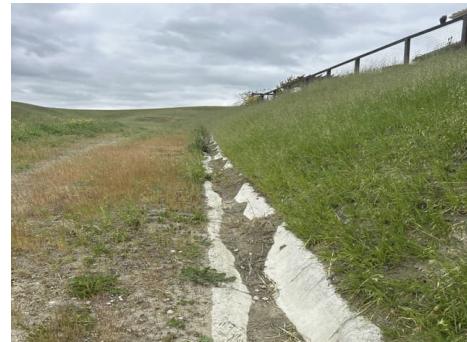
During our site visit, we observed several areas with surficial erosion to the slopes adjacent to the site improvements (Site Conditions B.1 through B.10, Appendix A, Figure 2). These areas will continue to be monitored during future monitoring events.

Site Condition: B.1
Observation Date: 04/17/2025
Description: Surficial slope erosion.

Recommendation: Continue to monitor.
Field Representative: EW

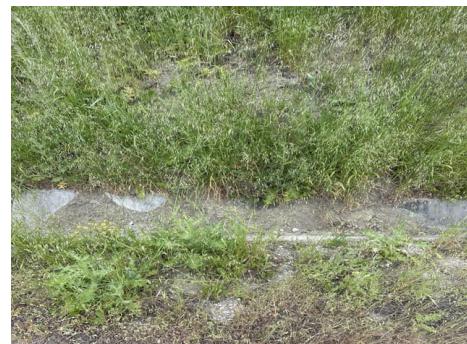
Site Condition: B.2
Observation Date: 04/17/2025
Description: Surficial slope erosion.

Recommendation: Continue to monitor.
Field Representative: EW

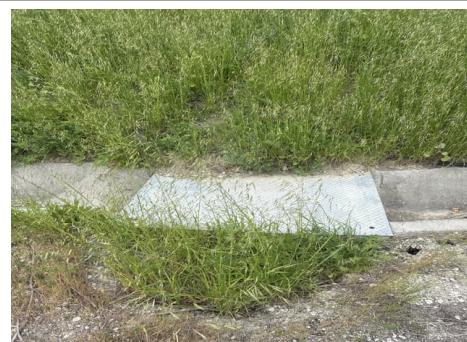
Site Condition: B.3
Observation Date: 04/17/2025
Description: Surficial slope erosion.

Recommendation: Continue to monitor.
Field Representative: EW

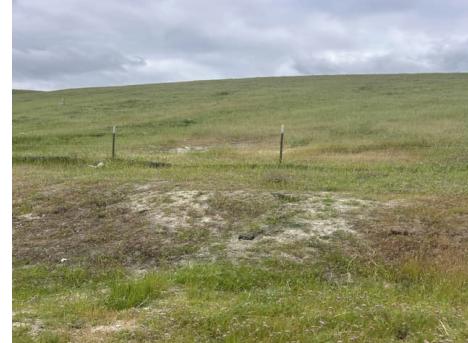
Site Condition: B.4
Observation Date: 04/17/2025
Description: Surficial slope erosion.

Recommendation: Continue to monitor.
Field Representative: EW

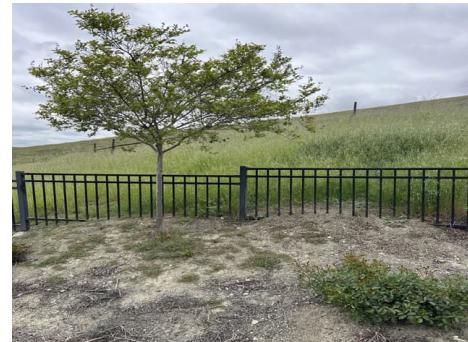
Site Condition: B.5
Observation Date: 04/17/2025
Description: Surficial slope erosion.

Recommendation: Continue to monitor
Field Representative: EW

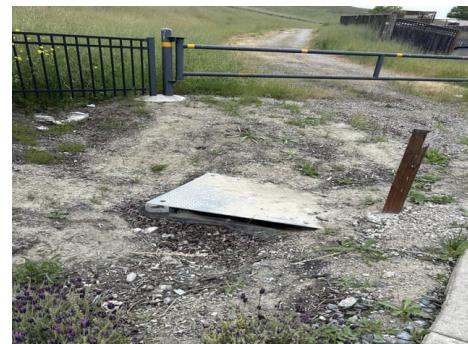
We observed various locations of earthen-lined drainage ditches containing large amounts of deposited sediments from slope erosion (Site conditions B.6 through B.8, Appendix A, Figure 2). The accumulated soil should be removed as part of annual maintenance.

Site Condition: B.6
Observation Date: 04/17/2025
Description: Surficial slope erosion and sedimentation in drainage ditch.

Recommendation: Remove sediments from drainage ditch during annual maintenance continue to monitor.
Field Representative: EW

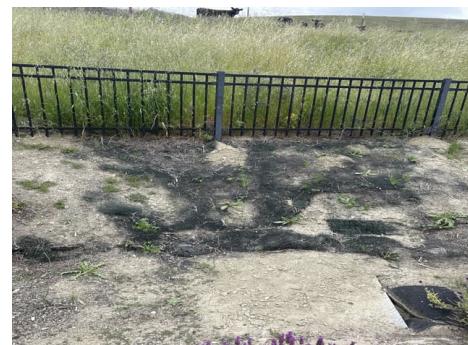
Site Condition: B.7
Observation Date: 04/17/2025
Description: Surficial slope erosion and sedimentation in drainage ditch.

Recommendation: Remove sediments from drainage ditch during annual maintenance and continue to monitor.
Field Representative: EW

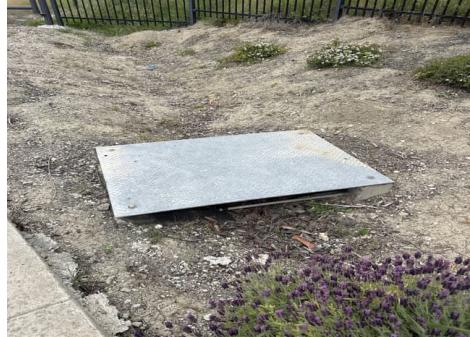
Site Condition:	B.8

Observation Date:	04/17/2025	
Description:	Surficial slope erosion and sedimentation in drainage ditch.	
Recommendation:	Remove sediments from drainage ditch during annual maintenance and continue to monitor	
Field Representative:	EW	
Site Condition:	B.9

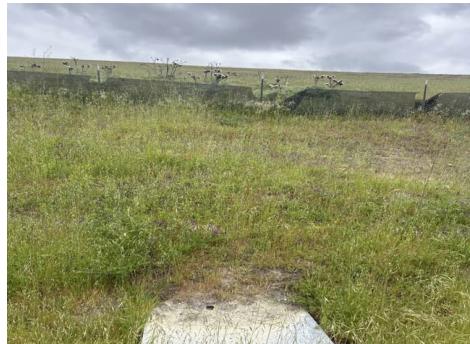
Observation Date:	04/17/2025	
Description:	Surficial slope erosion.	
Recommendation:	Continue to monitor.	
Field Representative:	EW	
Site Condition:	B.10

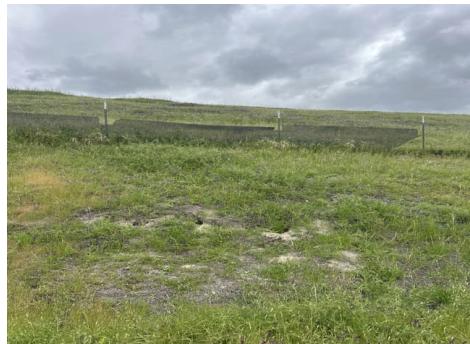
Observation Date:	04/17/2025	
Description:	Surficial slope erosion.	
Recommendation:	Continue to monitor.	
Field Representative:	EW	
Site Condition:	C.1

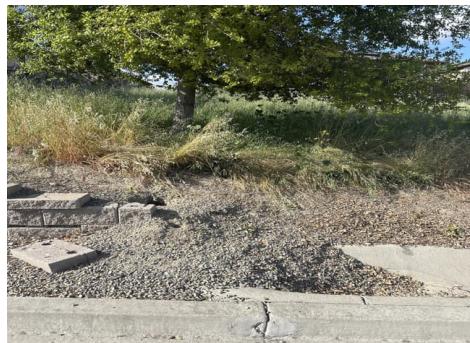
Animal burrows were observed during this monitoring event at various locations across the site (Figures 2 and 3). In some locations, the burrowing activity has deposited soil into the earthen- and concrete-lined ditches (Site Conditions C.1 and C.2, Appendix A, Figures 2 and 3). The deposited soil should be removed as part of annual maintenance.

Observation Date:	04/17/2025	
Description:	Animal burrowing.	
Recommendation:	Continue to monitor.	
Field Representative:	EW

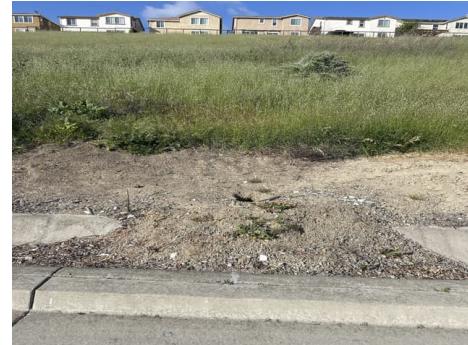
Site Condition: C.2
Observation Date: 04/17/2025
Description: Animal Burrowing.

Recommendation: Continue to monitor.
Field Representative: EW

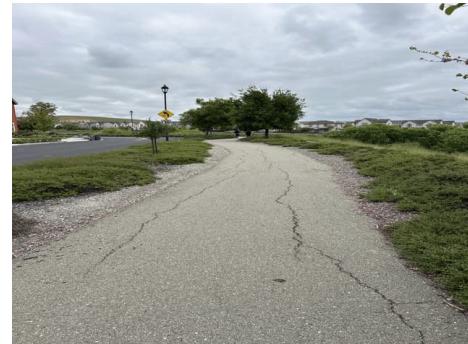
Since fall 2018, we have observed and noted the presence of cracks on the asphalt-paved trails that transect the Positano and Jordan Ranch developments. Most of these cracks are narrow, with some cracks that measure up to 40 feet long, 3 inches wide, and 5 inches deep. During the recent site monitoring event, we observed the cracking to be relatively unchanged (Site Conditions D.1 through D.4). It appears that expansive soil and soil creep are the possible causes of the distress to the trail surface. As a short-term solution, the cracks will be sealed or resealed as part of routine site maintenance.

Site Condition: D.1
Observation Date: 04/17/2025
Description: Distress cracking within asphaltic concrete trail.

Recommendation: Seal/reseal as needed.

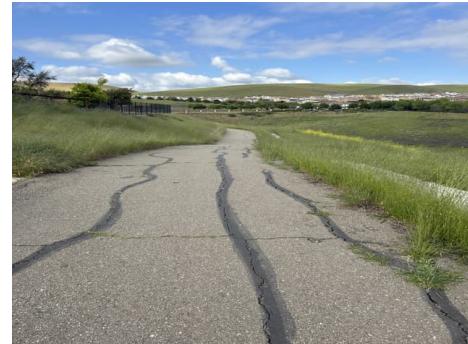
Site Condition: D.2
Observation Date: 04/17/2025
Description: Distress cracking within asphaltic concrete trail

Recommendation: Seal/reseal, as needed.

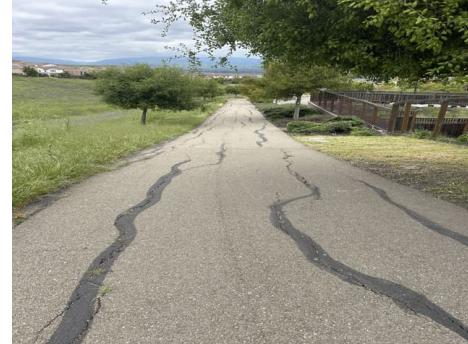
Site Condition: D.3
Observation Date: 04/17/2025
Description: Distress cracking in asphaltic concrete trail.

Recommendation: Seal/reseal, as needed.

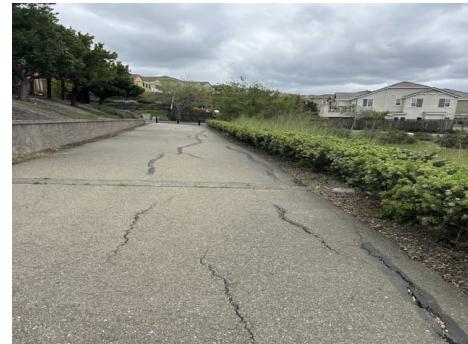
Site Condition: D.4
Observation Date: 04/17/2025
Description: Cracks in asphaltic concrete.

Recommendation: Seal/reseal as needed
Field Representative: EW

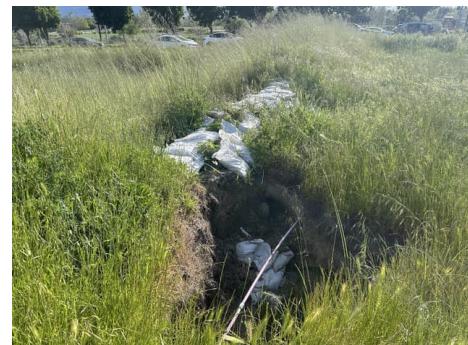
A berm, located in Bioretention Cell 2, failed during the heavy rain event in December 2022 and January 2023 (Site Condition E, Appendix A, Figure 2). The primary berm failure is approximately 4 feet in width, 3 feet in height, and 10 feet in length. During the spring 2024 monitoring event, we first observed a secondary berm failure approximately 5 feet to the east of the primary berm failure. At the time of our spring 2025 monitoring event, the secondary berm failure measured approximately 8 feet in width, 5 feet in height, and 4 feet in length.

The berm failure has resulted in a decreased capacity of the bioretention cell. A temporary repair has been implemented to the primary failure area, but the berm should be permanently repaired with engineered fill and excess soil removed to ensure design capacity is maintained.

Site Condition: E
Observation Date: 04/17/2025
Description: Bioretention cell berm failure.
Recommendation: Earthwork repair with geo-grid to reinforce berm.
Field Representative: EW

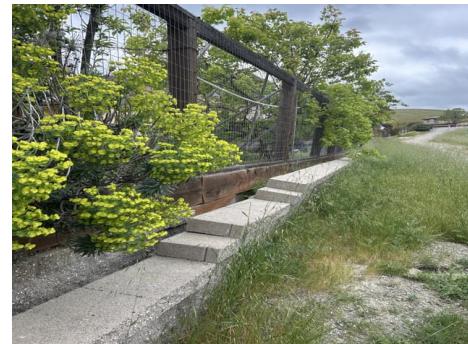
During the fall 2024 monitoring event, we observed distress in the retaining wall to the east of Moorjani Street (Site Condition F, Appendix A, Figure 2). The retaining wall was observed leaning away from the adjacent fence at an angle approximately 15 to 20 degrees from vertical. During this monitoring event, the condition of the wall appeared to be unchanged. The GHAD will continue to monitor this condition and note in future monitoring reports if any changes are observed.

Site Condition: F
Observation Date: 04/17/2025
Description: Leaning of retaining wall along residences.
Recommendation: Continue to monitor.
Field Representative: EW

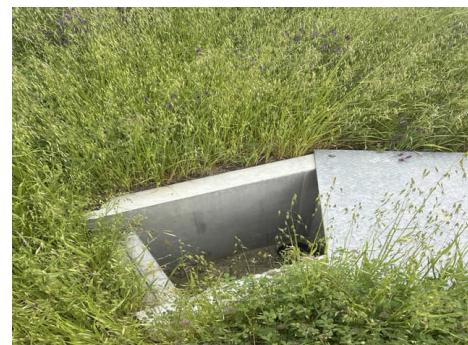
During the fall 2024 monitoring event, we observed a drain inlet cover to the northeast of Atella Court was partially removed and sediments had accumulated in the bottom of the drain inlet (Site Condition G, Appendix A, Figure 2). At the time of the spring 2025 monitoring event, the condition of the drain inlet cover was unchanged. As a part of annual maintenance, the accumulated sediments will be removed and the drain cover will be reattached. Other storm drain inlets within the open-space area of the GHAD appeared to be relatively clear of debris.

Site Condition: G
Observation Date: 04/17/2025
Description: Drain inlet cover partially detached.
Recommendation: Reattach drain inlet cover.
Field Representative: EW

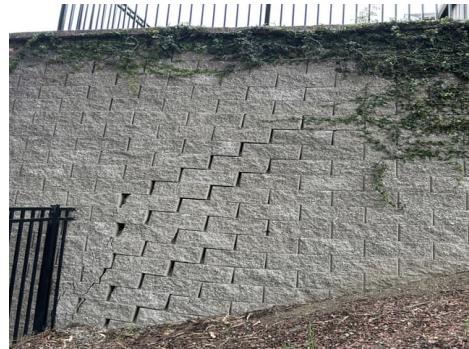
Site Condition: H
Observation Date: 04/17/2025

As first observed in 2016 (Reference 5), there is distress in the upper and lower retaining walls within the southeastern corner of the retaining wall to the south of Central Parkway (Site Condition H, Appendix A, Figure 3). Existing distress is concentrated in the southwestern corner of the lower retaining wall tier, with gaps ranging from $\frac{1}{4}$ inch to 1 inch between blocks. During this monitoring event, we observed no significant change in the visible distress. The GHAD will continue to monitor the retaining wall and note in future monitoring reports if any changes are observed.

Description: Wall Distress

Recommendation: Continue to Monitor
