Project No.
4663.002.019

June 24, 2020

Subject: Jordan Ranch Development
Positano Development
Dublin, California

**GEOLOGIC HAZARD ABATEMENT DISTRICT
MONITORING – SPRING 2020**

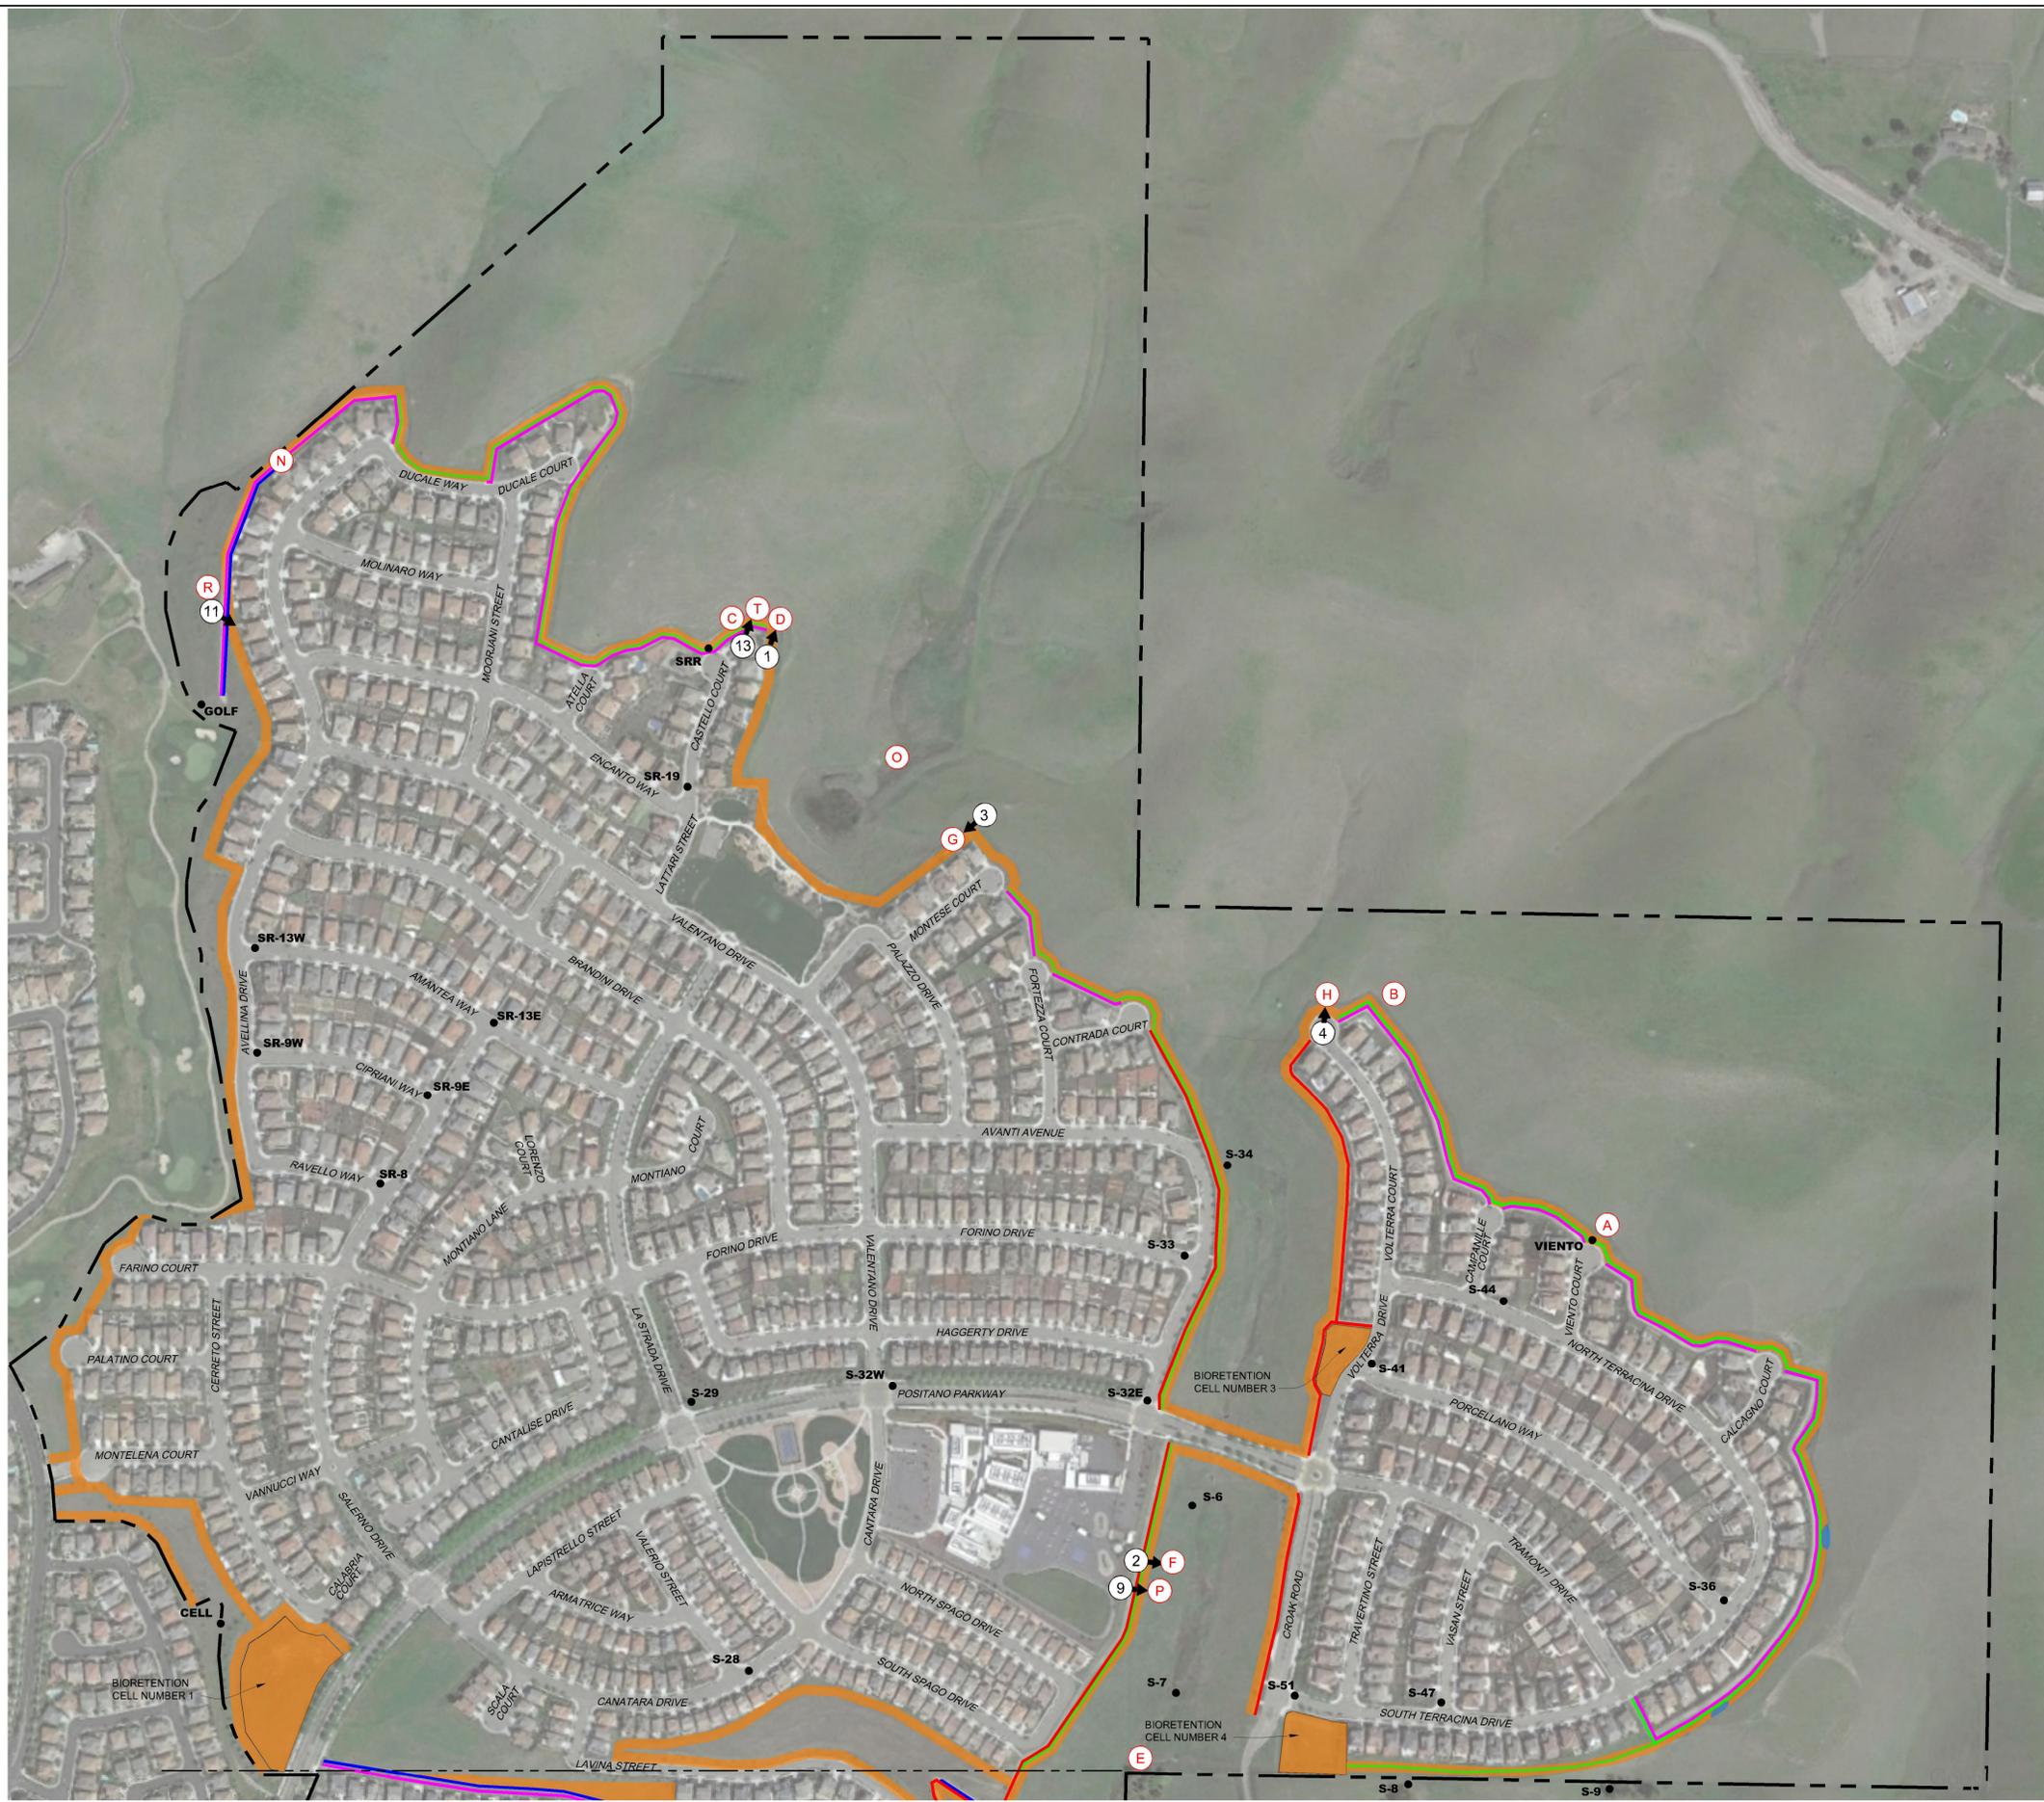
Open-space slopes, debris benches, and swales were observed for evidence of slope instability, including landslides, mudflows, erosion, diverted drainage, or standing water. During our site visit, we observed several areas of significant distress to the slopes adjacent to the site improvements.

To the east of the previously mentioned landslide (Site Condition C), there was a minor landslide that appears to be caused by numerous shallow animal burrows (Figure 2, Site Condition D, Photograph 1). The landslide measures approximately 15 feet in width, 10 feet in length, and has a head scarp of about 1 foot in height. The material deposited by the landslide was deposited in the earthen-lined drainage ditch located at the base of the slope. The GHAD will remove the deposited material and restore the earthen-lined drainage ditch. During our most recent monitoring event, it appears that another shallow failure has occurred as a result of the burrowing activity. This failure does not impact any nearby improvements and the GHAD will continue to monitor this slope.

Within the open space north of Montese Court, we observed unauthorized homeowner improvements outside the property fence of 2101 Montese Court and 2109 Montese Court (Figure 2, Site Condition G, Photograph 3). The GHAD has notified the homeowners that these improvements are not allowed within the GHAD-owned open space and the GHAD has requested their removal. The homeowner has removed the fencing that was previously installed on the GHAD property; however, improvements to the slope between lots remains. This debris should also be removed and the GHAD will notify the homeowners.

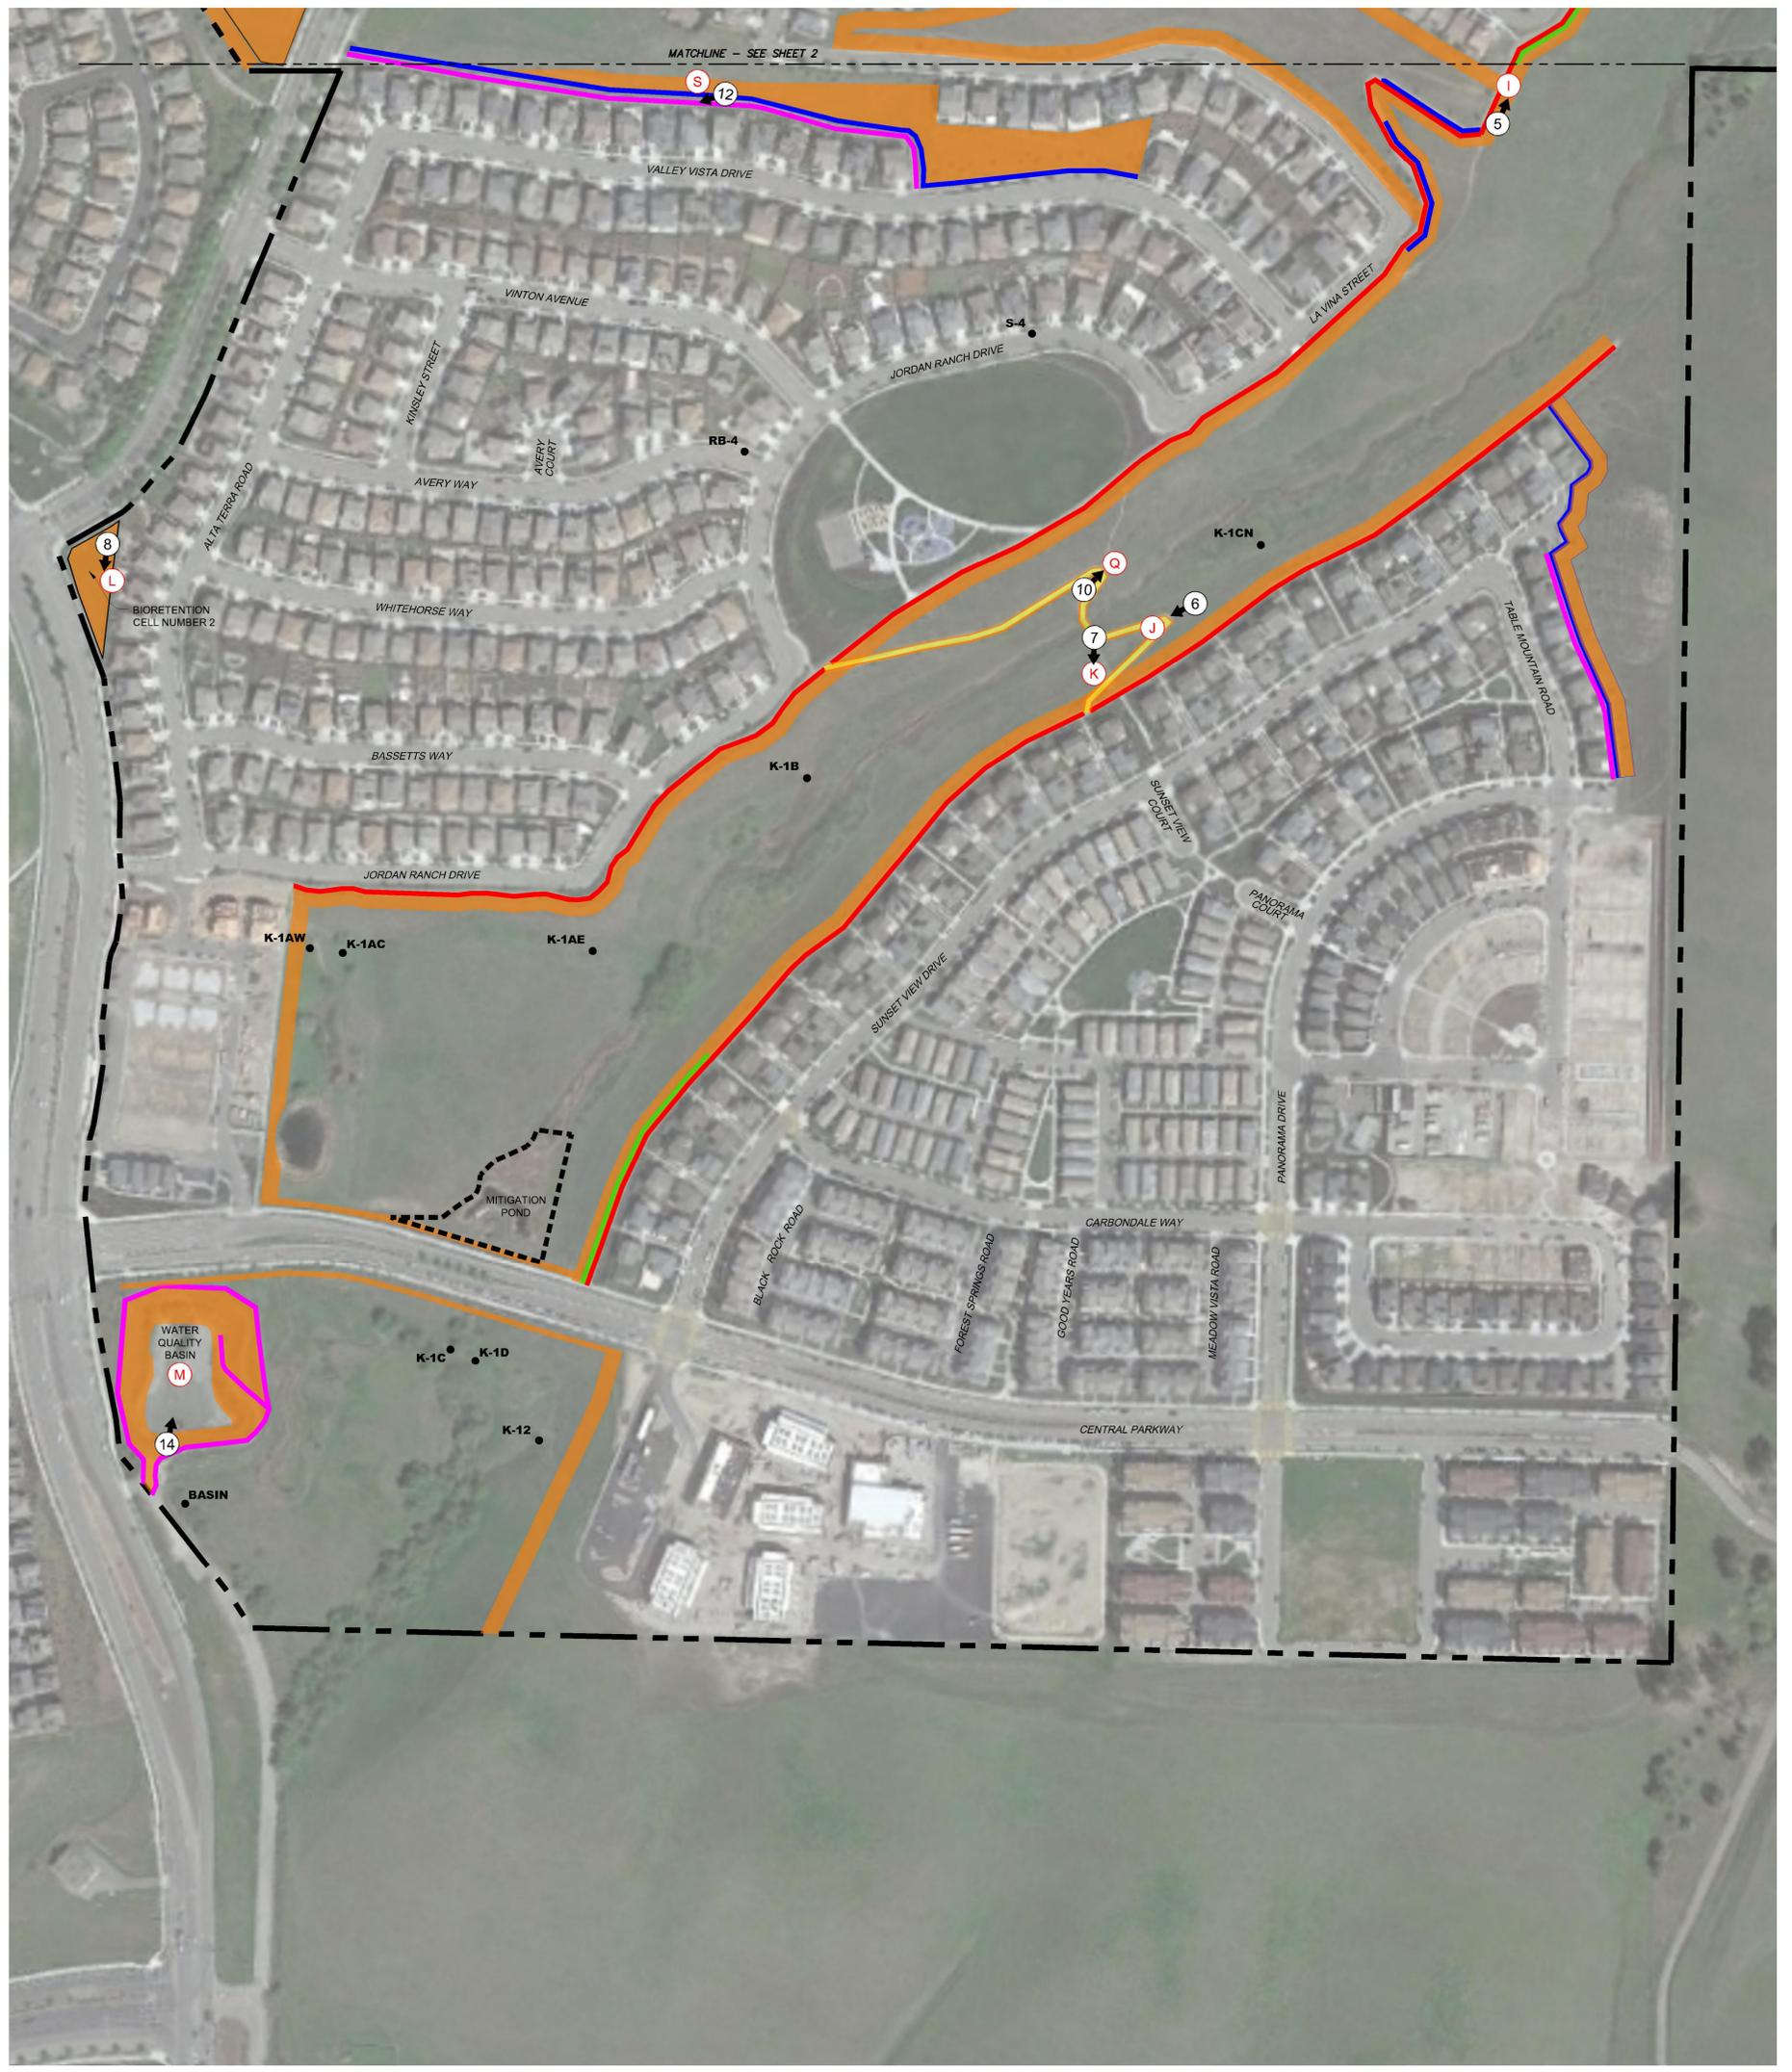
In several areas on the asphaltic concrete surfaced trails, there were lineal cracks that run parallel to the edge of the trail. Most of these cracks were relatively narrow and will be sealed or resealed as part of routine site maintenance. At the northern edge of the Jordan Ranch development, we observed cracks up to 40 feet long, 3 inches wide, and 5 inches deep allowing surface water to saturate the subgrade materials (Figure 3, Site Condition I, Photograph 5). It

A decomposed granite-surfaced trail crosses through the creek in the Jordan Ranch development. The trail was in moderately good condition with the exception of erosion gullies at various locations on the trail (Figure 3, Site Condition J, Photograph 6). The GHAD will backfill the erosion gullies and continue to monitor the trail during future monitoring events.

At several points adjacent to the trail, there were unauthorized paths that deviate from the designated trail (Figure 3, Site Condition K, Photograph 7). Bare soil was exposed on the unauthorized trail segments. We have not observed erosion on the unauthorized trails, but a shallow depression was observed adjacent to the trail (Figure 3, Site Condition Q, Photograph 10). The unauthorized trail segments will be monitored during future scheduled monitoring events.

An erosion gully has formed along the eastern edge of Bioretention Cell No. 2 between the upper and lower bioretention cells (Figure 3, Site Condition L, Photograph 9). The gully developed during the 2016/2017 winter and increased in size during the 2018/19 winter rainy season. The GHAD installed temporary sandbags to buttress the berm and prevent further erosion in Fall/Winter 2018. As described in the attached monitoring report, the GHAD will rebuild the berm in 2020 when drier weather allows earthwork activities.

During the fall 2017 monitoring event, standing water was observed within the water quality basin in the Jordan Ranch development (Figure 3, Site Condition M, Photograph 14). Clayey sediments deposited on top of the filter medium prevented water from infiltrating properly. In March 2018, the GHAD performed a temporary repair by pumping the standing water out of the basin, excavating clayey material adjacent to the outfall structure, exposing the existing subdrain and backfilling the excavation with riprap to allow water to drain properly. A permanent repair involving removal of the clayey materials and the upper portion of the filter medium has been scheduled in 2020. At the time of our most recent monitoring, standing water was present within the water quality basin. A permanent repair will be necessary to remove the water and restore proper function to the basin.
