ENGEOTM INCORPORATED, GHAD Consultant

June 28, 2024

Subject: Jordan Ranch and Positano Developments
Dublin, California

GEOLOGIC HAZARD ABATEMENT DISTRICT MONITORING SPRING 2024

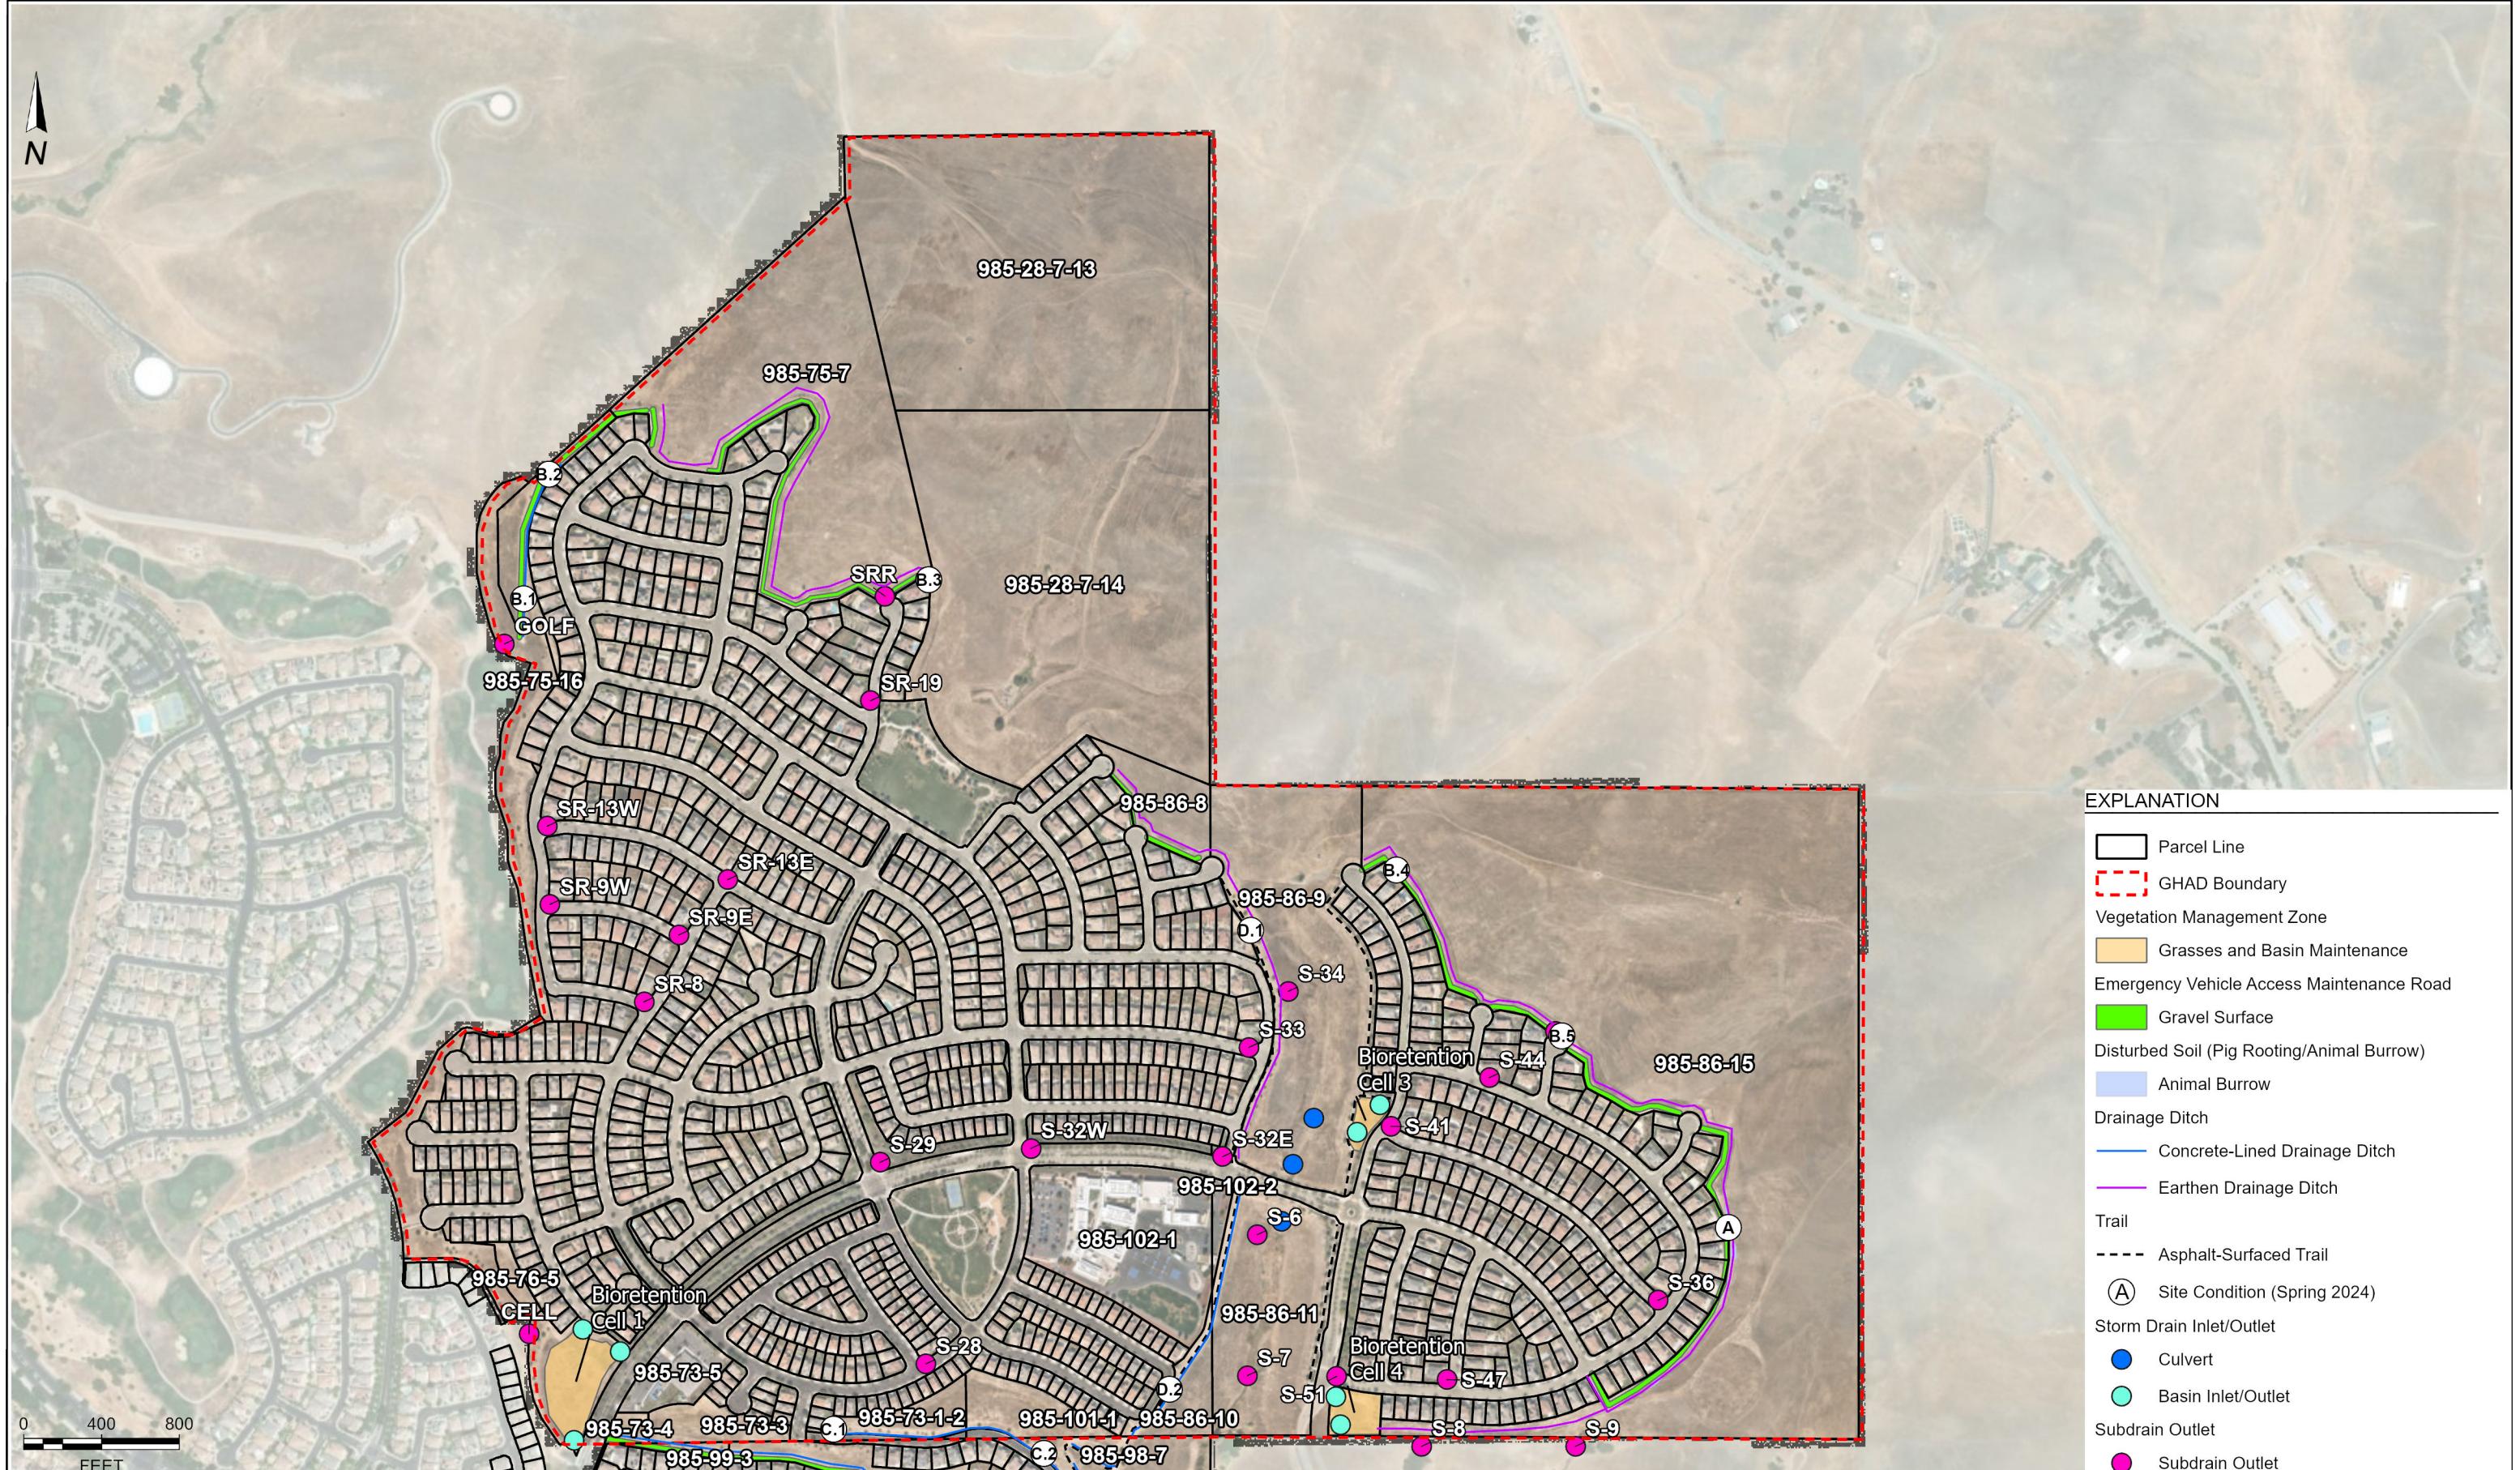
During fall 2023, a surficial slope failure measuring approximately 6 feet in width, 10 feet in length, and 1 foot in depth was observed east of N Terracina Drive. During this monitoring event, the slope failure appeared to be unchanged and partially vegetated (Site Condition A, Appendix A, Figure 2). The GHAD will continue to monitor this condition and repair the slope failure, if needed.

During our site visit, we observed several areas with surficial erosion to the slopes adjacent to the site improvements (Site Conditions B.1 through B.5, Appendix A, Figure 2). These areas will continue to be monitored during future monitoring events.

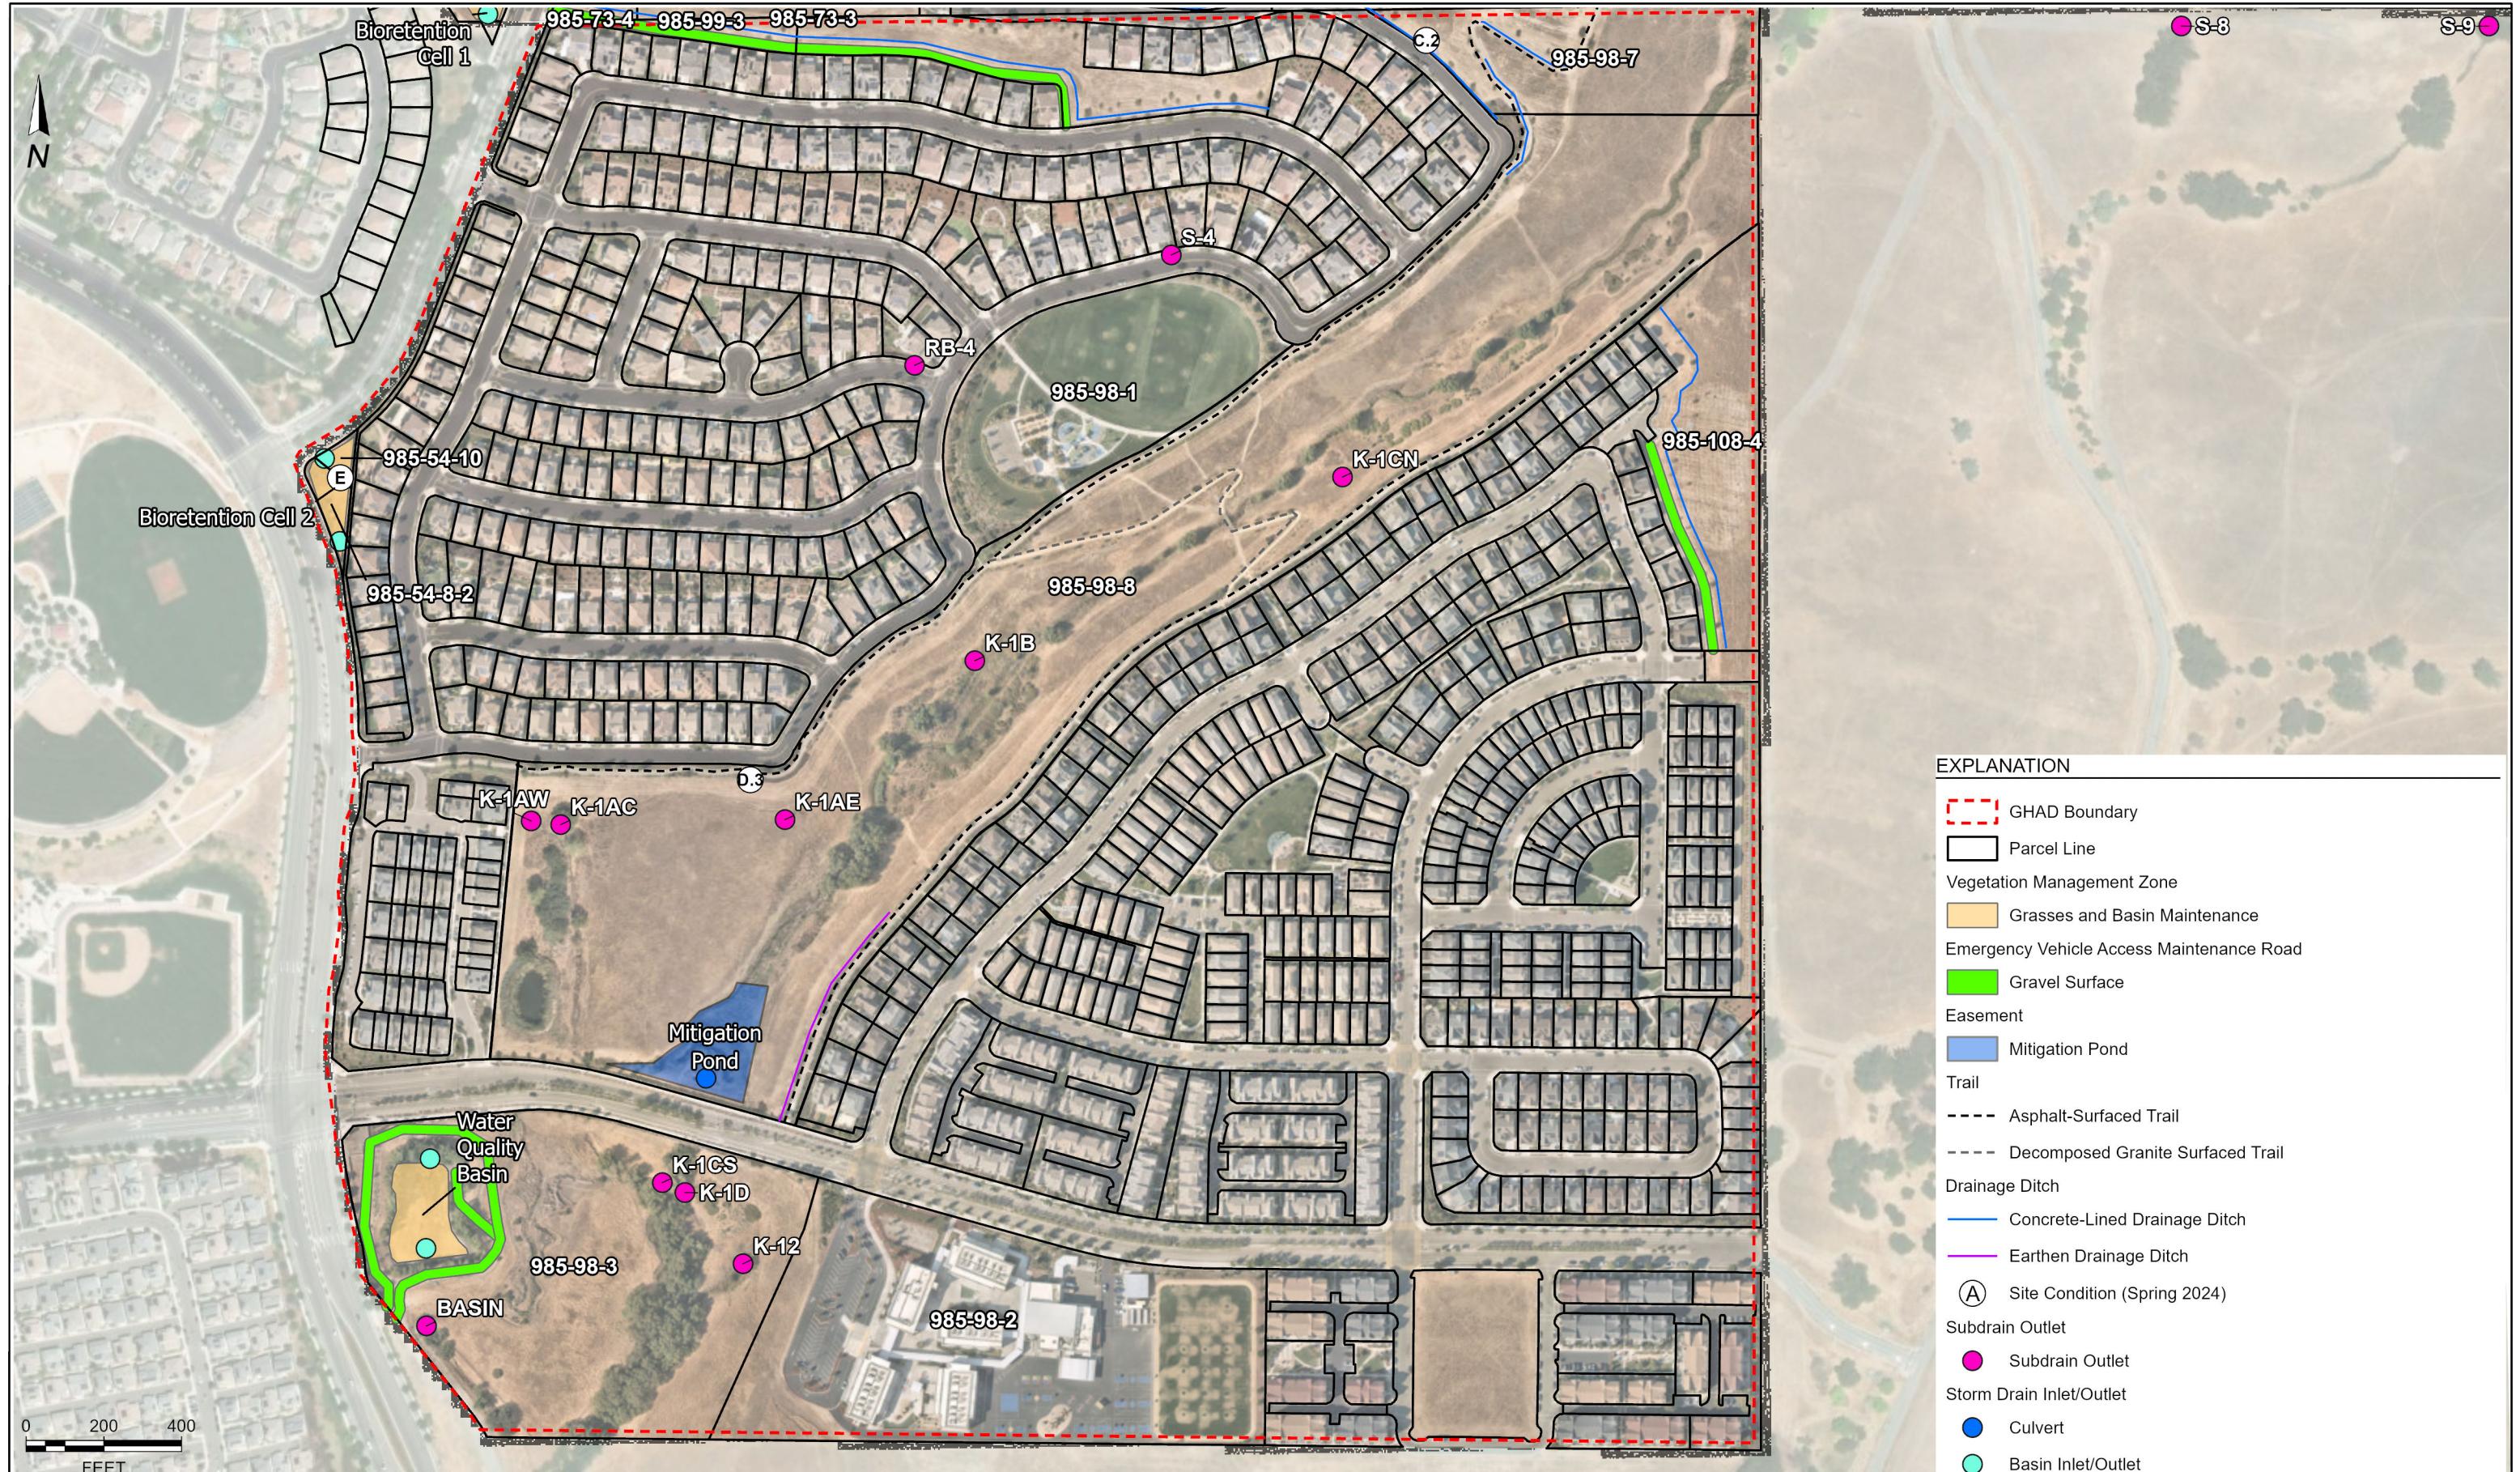
Animal burrows were observed during this monitoring event at various locations across the site (Figures 2 and 3). In some locations, the burrowing activity has deposited soil into the earthen- and concrete-lined ditches (Site Conditions C.1 and C.2, Appendix A, Figures 2 and 3). The deposited soil should be removed as part of annual maintenance.

Concrete-lined drainage ditches were checked for accumulation of debris/sediment and for obvious distress, such as cracking or shifting of the concrete. As shown in Figures 2 and 3, there are approximately 4,650 linear feet of concrete-lined drainage ditches within the Fallon Village GHAD. As part of the scheduled routine site maintenance, the GHAD removes vegetation, soil, and other unwanted material from the concrete-lined ditches. We observed minor cracks in the concrete ditches. At the time of the site visit, these minor cracks did not appear to compromise the integrity of the concrete-lined drainage ditches and will be patched as needed.
