April 29, 2025

Subject: Jordan Ranch and Positano Developments
Dublin, California

GEOLOGIC HAZARD ABATEMENT DISTRICT MONITORING SPRING 2025

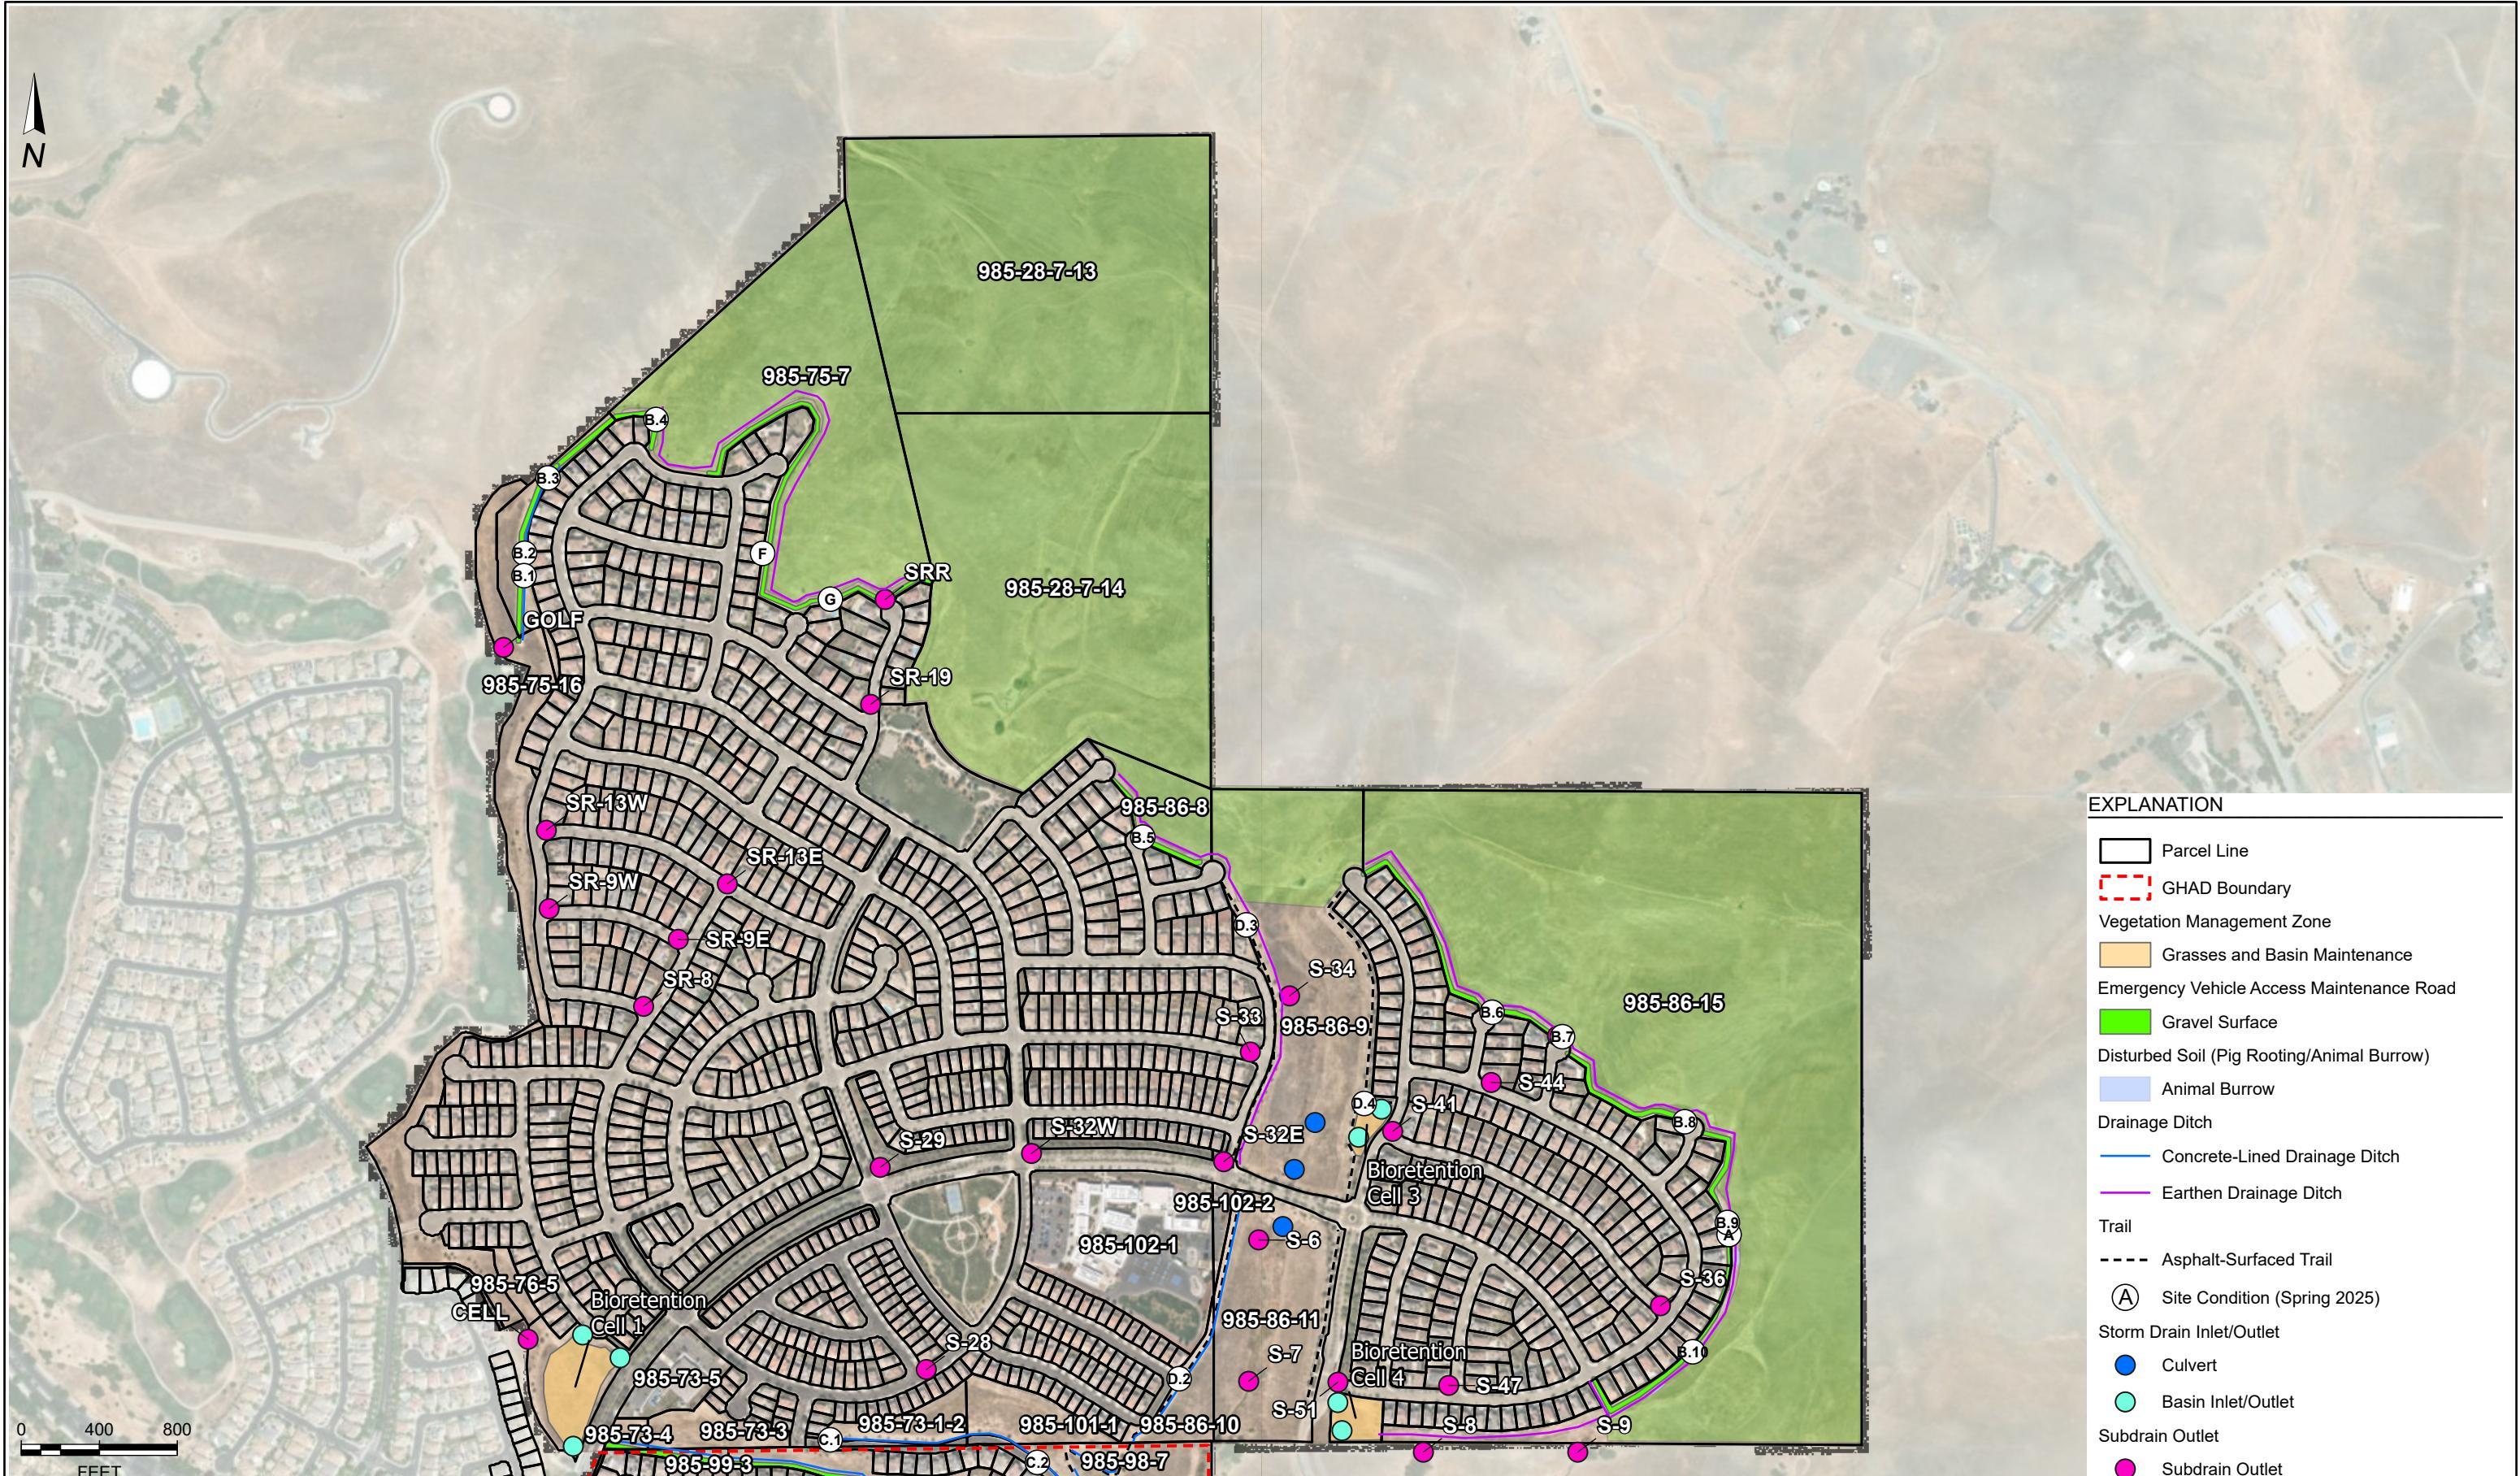
During the fall 2024 monitoring event, we observed distress in the retaining wall to the east of Moorjani Street (Site Condition F, Appendix A, Figure 2). The retaining wall was observed leaning away from the adjacent fence at an angle approximately 15 to 20 degrees from vertical. During this monitoring event, the condition of the wall appeared to be unchanged. The GHAD will continue to monitor this condition and note in future monitoring reports if any changes are observed.

A berm, located in Bioretention Cell 2, failed during the heavy rain event in December 2022 and January 2023 (Site Condition E, Appendix A, Figure 2). The primary berm failure is approximately 4 feet in width, 3 feet in height, and 10 feet in length. During the spring 2024 monitoring event, we first observed a secondary berm failure approximately 5 feet to the east of the primary berm failure. At the time of our spring 2025 monitoring event, the secondary berm failure measured approximately 8 feet in width, 5 feet in height, and 4 feet in length.

During the fall 2024 monitoring event, we observed a drain inlet cover to the northeast of Atella Court was partially removed and sediments had accumulated in the bottom of the drain inlet (Site Condition G, Appendix A, Figure 2). At the time of the spring 2025 monitoring event, the condition of the drain inlet cover was unchanged. As a part of annual maintenance, the accumulated sediments will be removed and the drain cover will be reattached. Other storm drain inlets within the open-space area of the GHAD appeared to be relatively clear of debris.

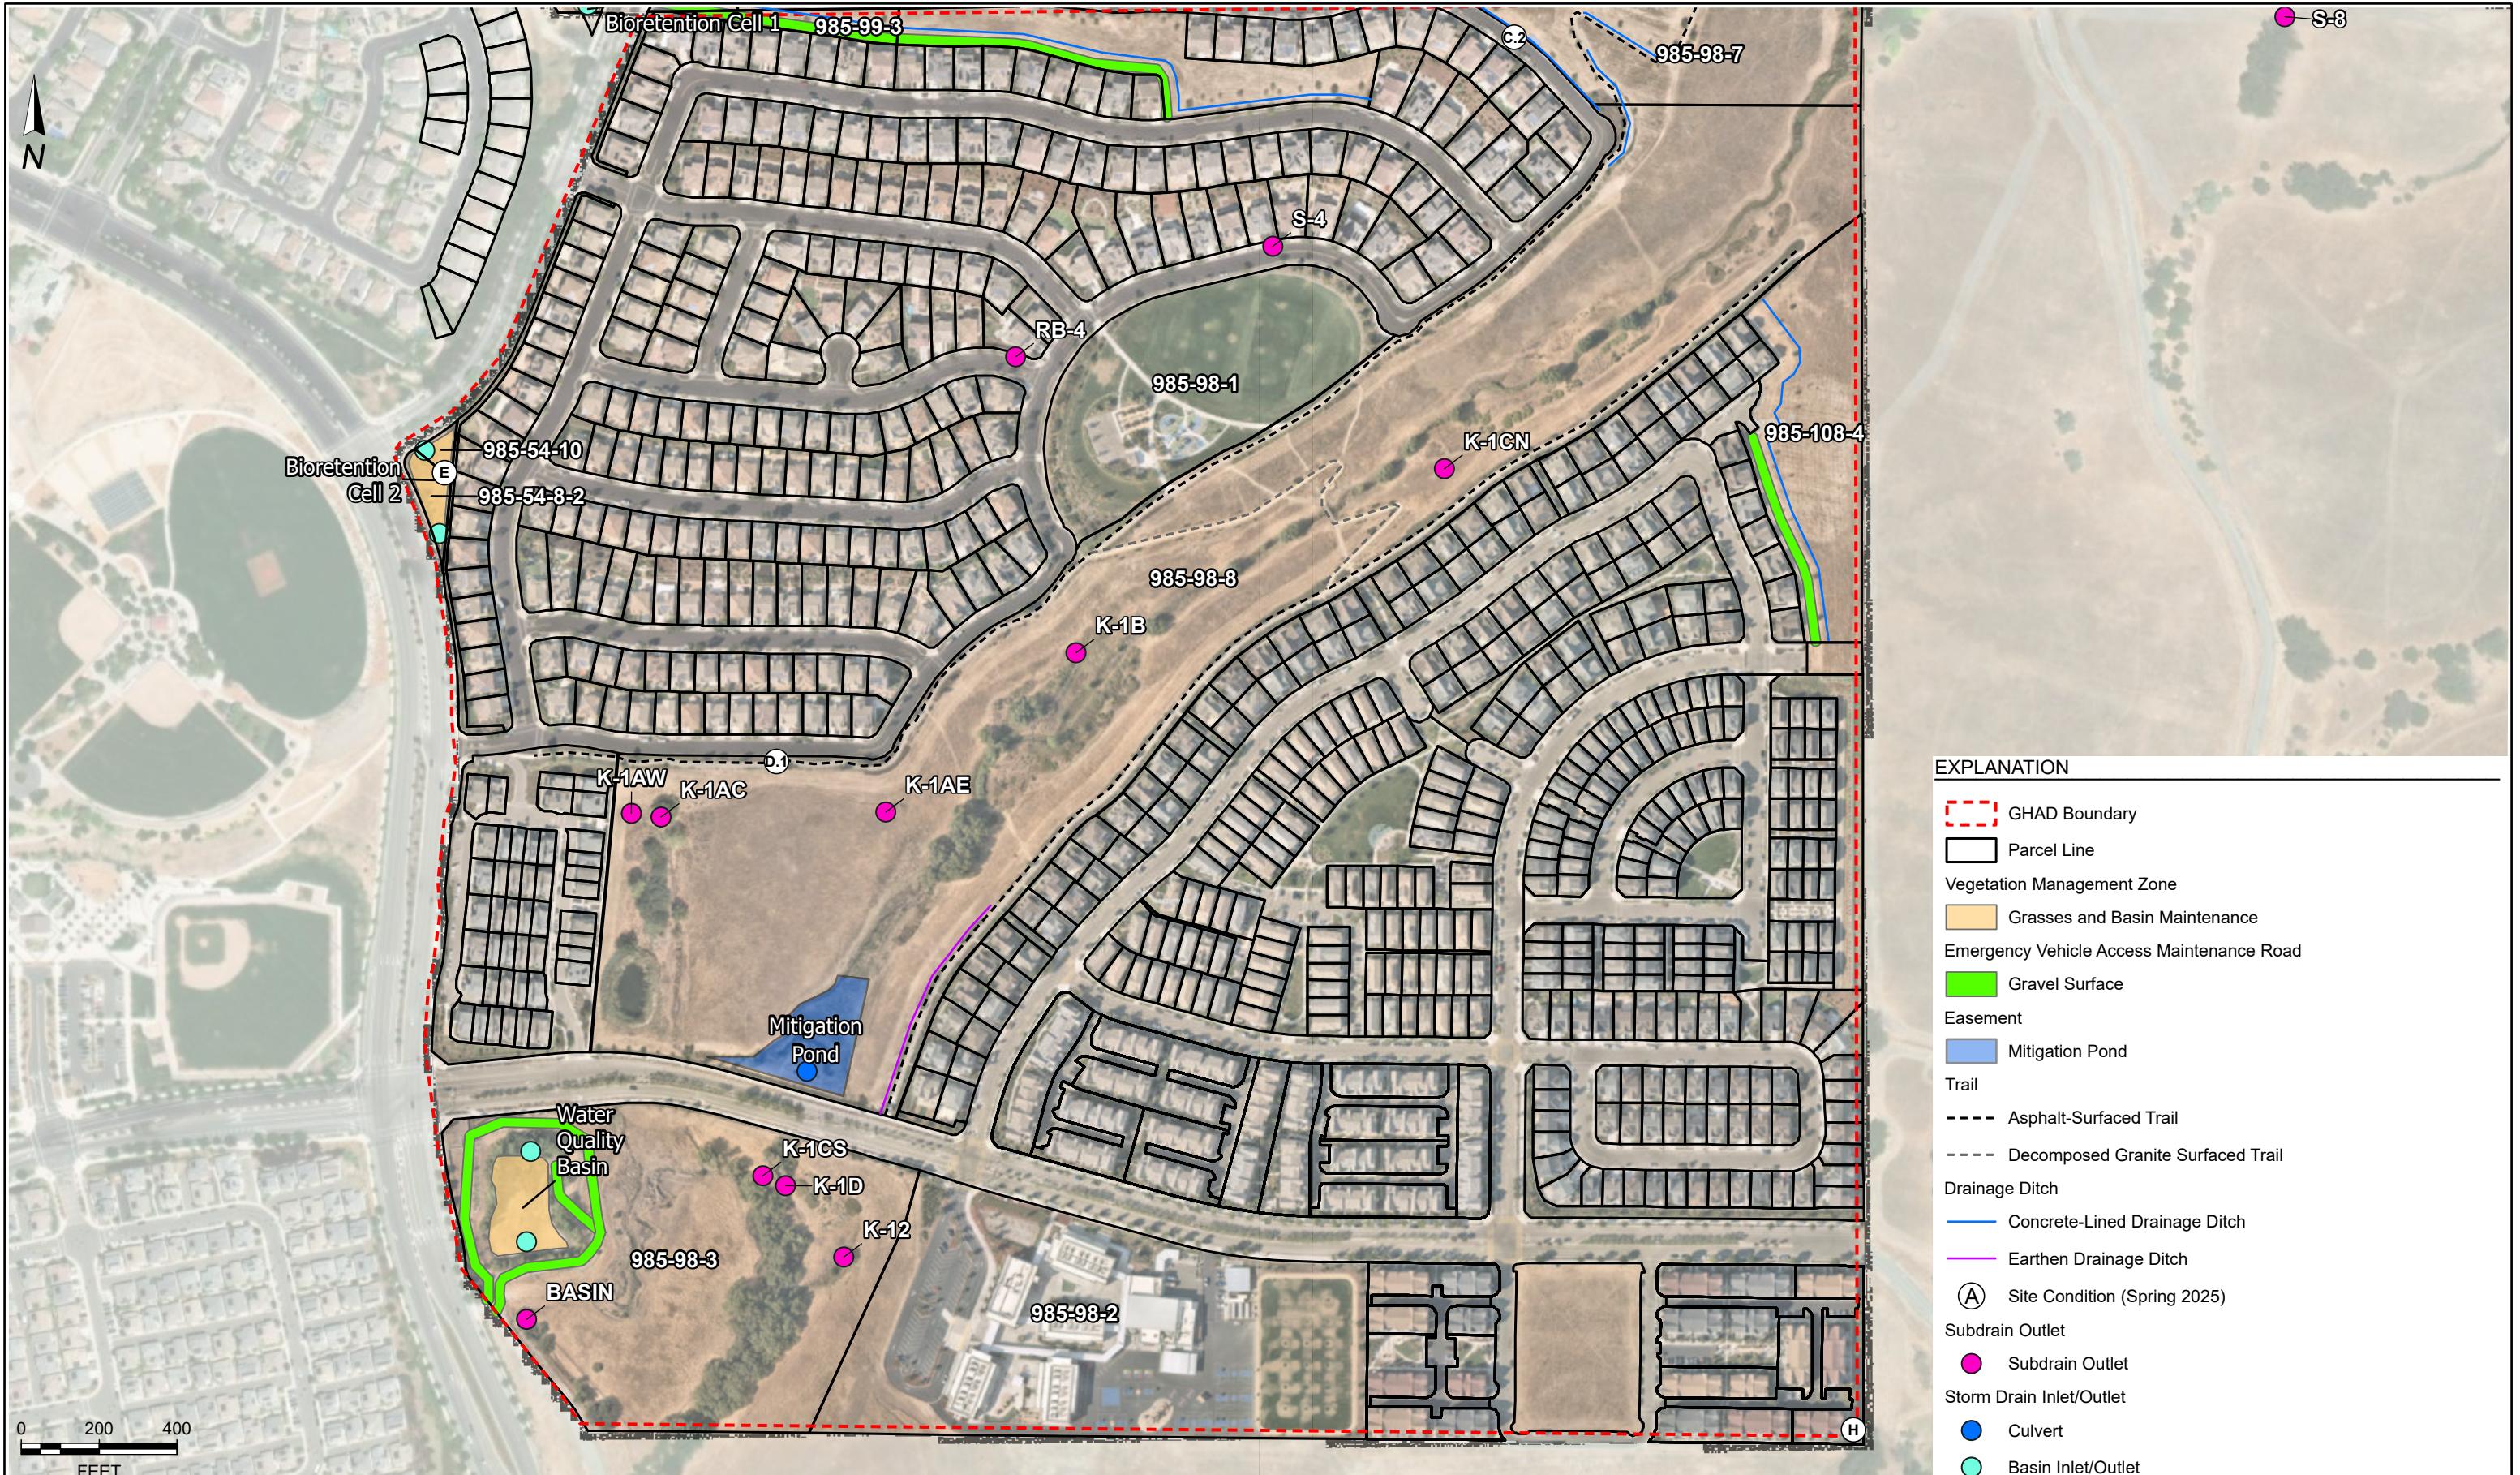
As first observed in 2016 (Reference 5), there is distress in the upper and lower retaining walls within the southeastern corner of the retaining wall to the south of Central Parkway (Site Condition H, Appendix A, Figure 3). Existing distress is concentrated in the southwestern corner of the lower retaining wall tier, with gaps ranging from $\frac{1}{4}$ inch to 1 inch between blocks. During this monitoring event, we observed no significant change in the visible distress. The GHAD will continue to monitor the retaining wall and note in future monitoring reports if any changes are observed.
