**FALLON VILLAGE  
GEOLOGIC HAZARD  
ABATEMENT DISTRICT (GHAD)**

**PLAN OF CONTROL  
JORDON RANCH DEVELOPMENT ANNEXATION**

**Prepared by  
ENGEO Incorporated**

**Project No. 7828.000.000  
February 11, 2011**

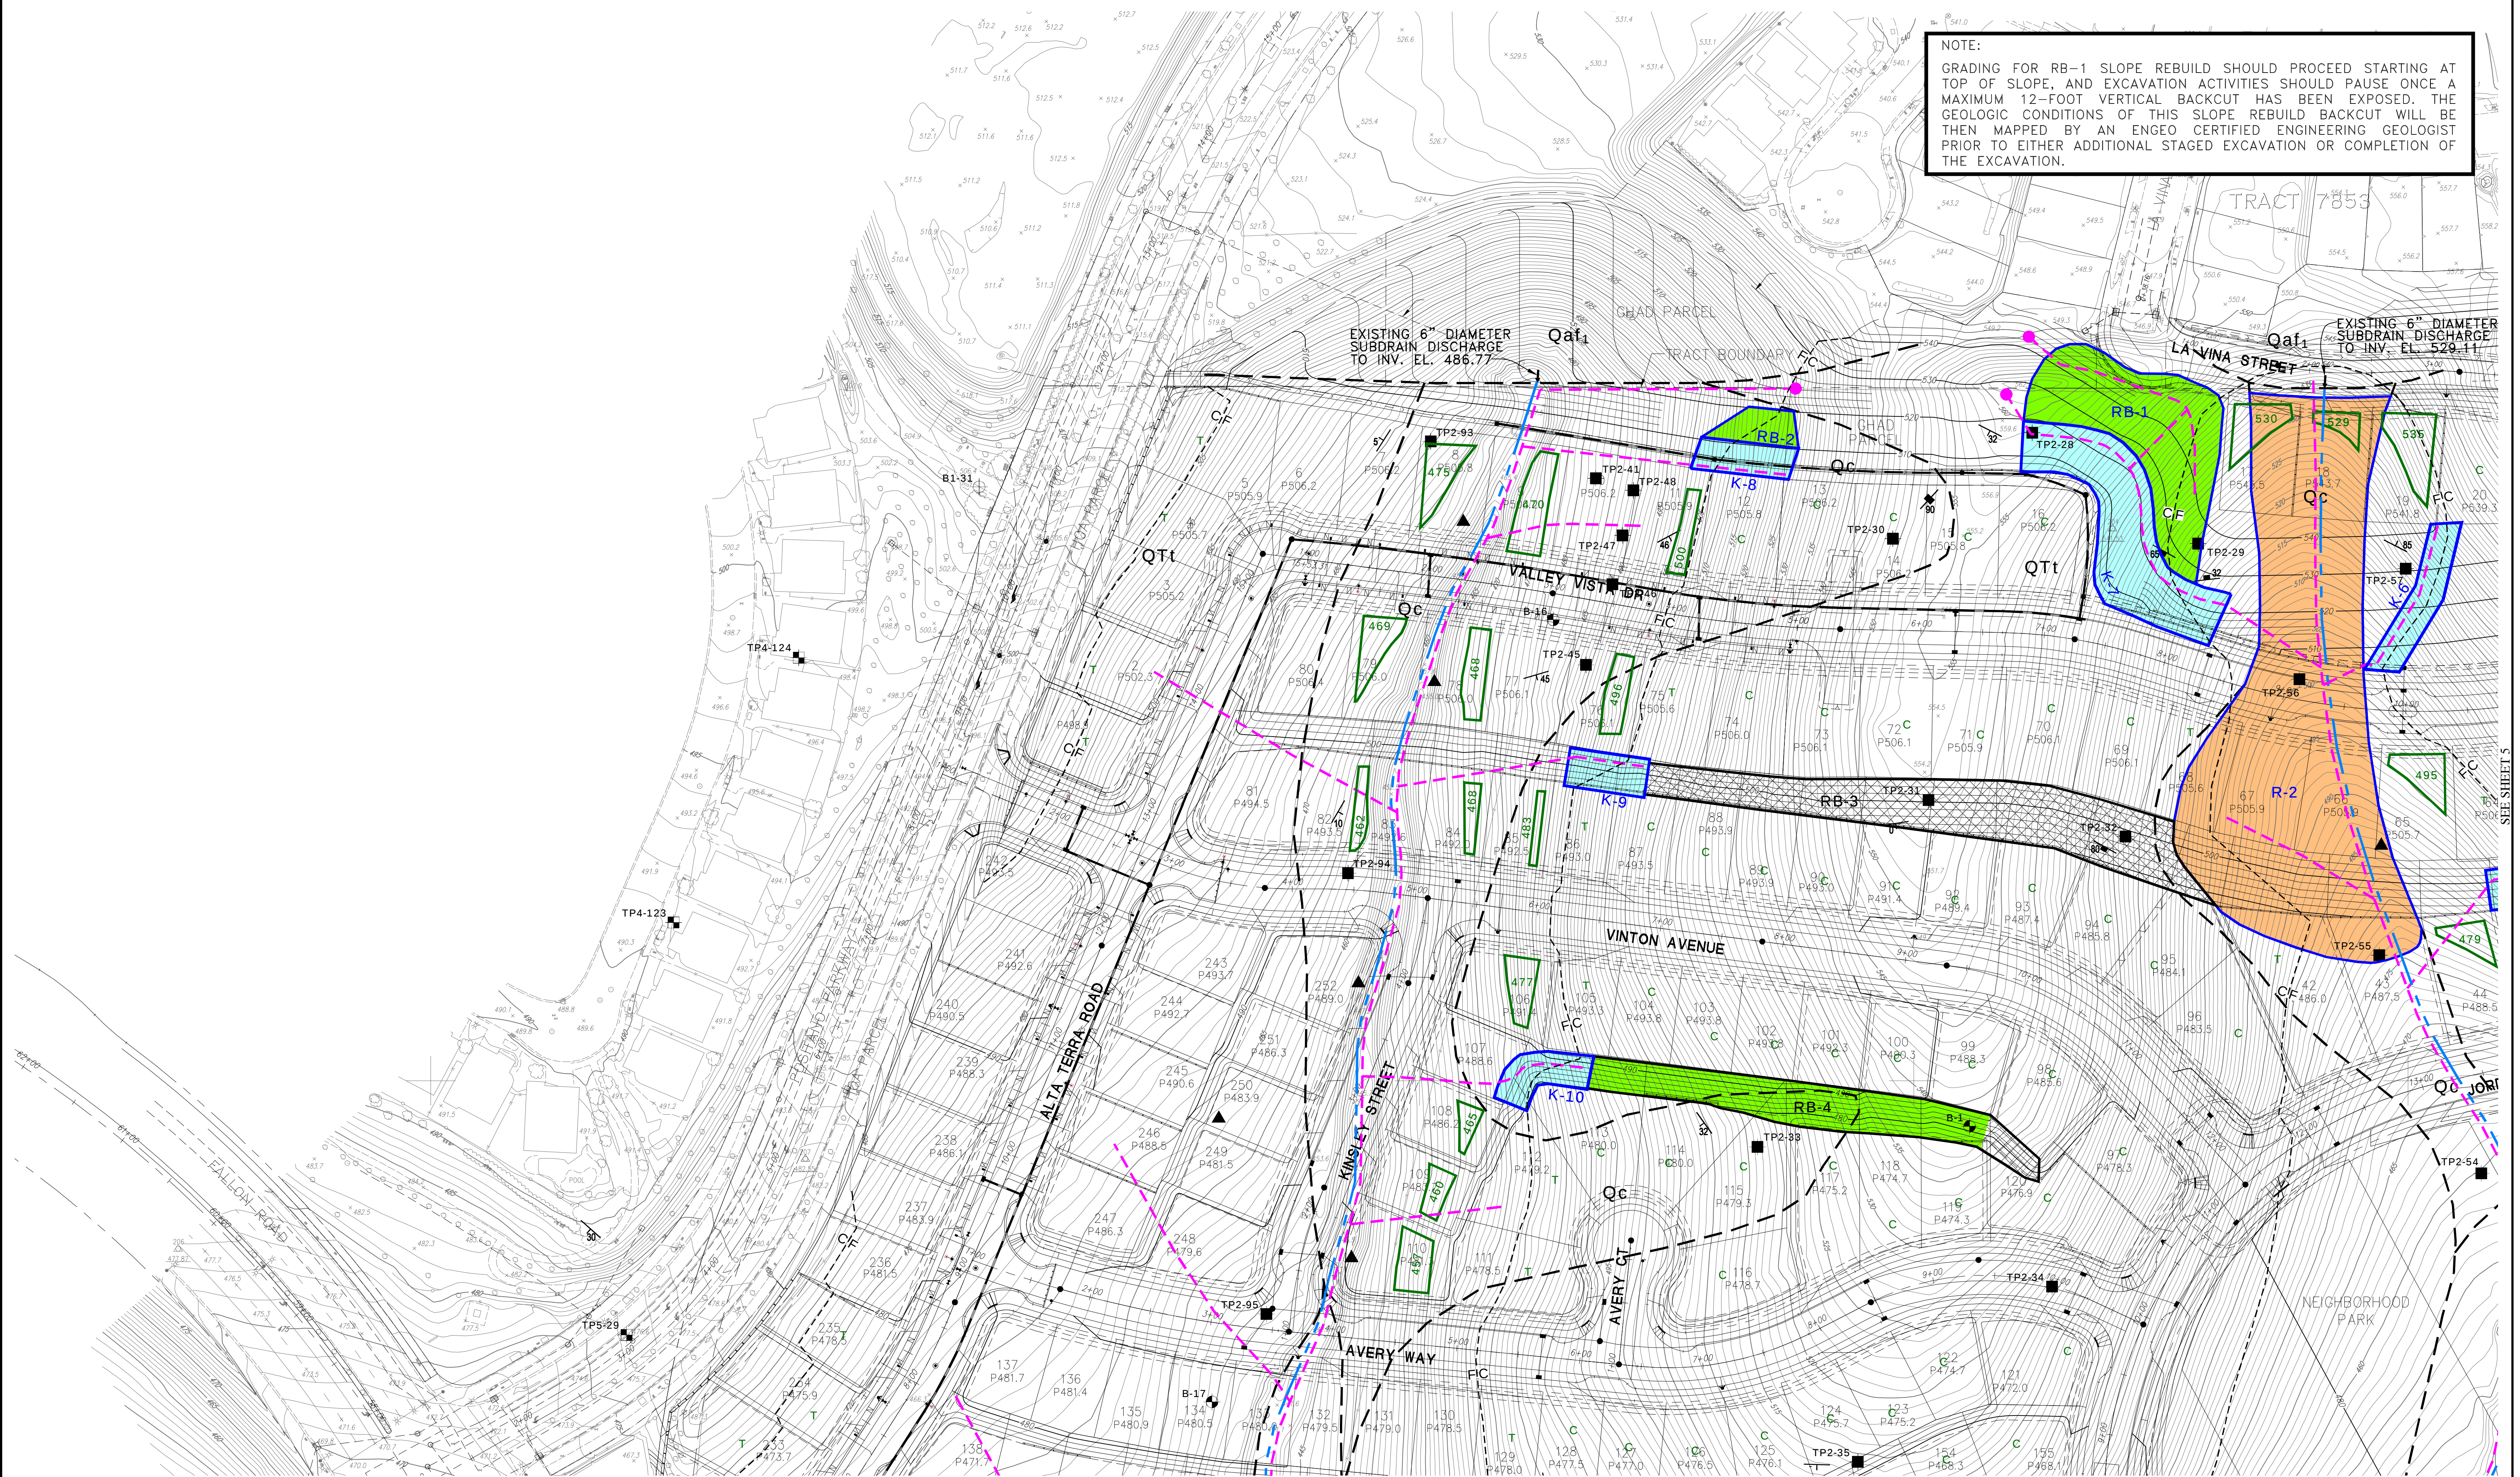
NOTE:  
GRADING FOR RB-1 SLOPE REBUILD SHOULD PROCEED STARTING AT TOP OF SLOPE, AND EXCAVATION ACTIVITIES SHOULD PAUSE ONCE A MAXIMUM 12-FOOT VERTICAL BACKCUT HAS BEEN EXPOSED. THE GEOLOGIC CONDITIONS OF THIS SLOPE REBUILD BACKCUT WILL BE THEN MAPPED BY AN ENGeo CERTIFIED ENGINEERING GEOLOGIST PRIOR TO EITHER ADDITIONAL STAGED EXCAVATION OR COMPLETION OF THE EXCAVATION.
